Standard Checklist

Name of Riparian-Wetland Area: Potrero Creek

Date: May 21, 2004 Segment/Reach ID: Reach 3 - Behind Tennis Courts PFC 102

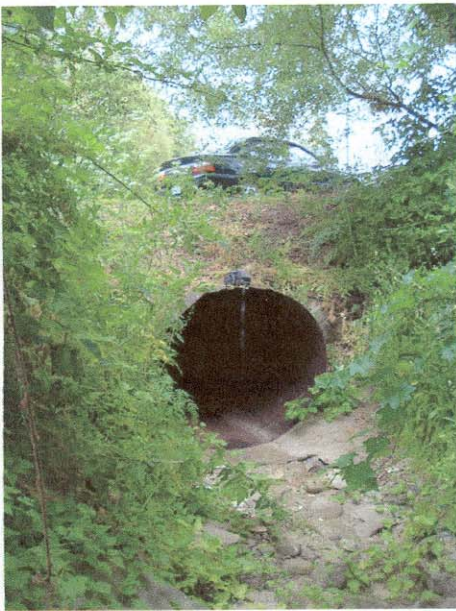
Picture 1

The large culvert is becoming undermined as water runs under it and has a large bend in it that could be a fish impairment (See Picture 1). There is a large sediment drop just downstream from the culvert which alters the bed composition for at least 50 yds, after which the bed returns to a cobble/gravel mix (See Picture 4).

The creek bank is steep and at least 13 ft. high (See Pictures 1, and 2)).

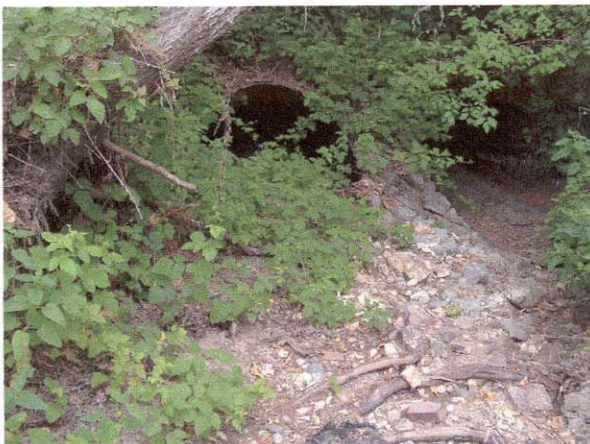
Picture 3

At the end of the reach are two more culverts that are much smaller at only ~2 ft. and ~3 ft. in diameter (See Picture 3)
