Standard Checklist

Name of Riparian-Wetland Area: Potrero Creek

Date: June 17, 2004 Segment/Reach ID: Reach 1 PFC 104

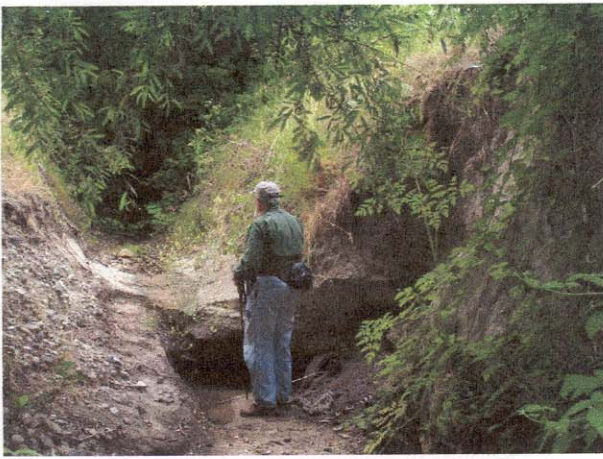
Picture 1

The concrete foundations of a removed culvert are starting to erode and undercutting is occurring (See Picture 1).

There is serious erosion just downstream where part of a bank collapsed, and headcutting and incising is occurring in the creek bed (See Pictures 1 and 2).

The concreted bridge foundation at the end of the reach is being undercut (See Pictures 1).

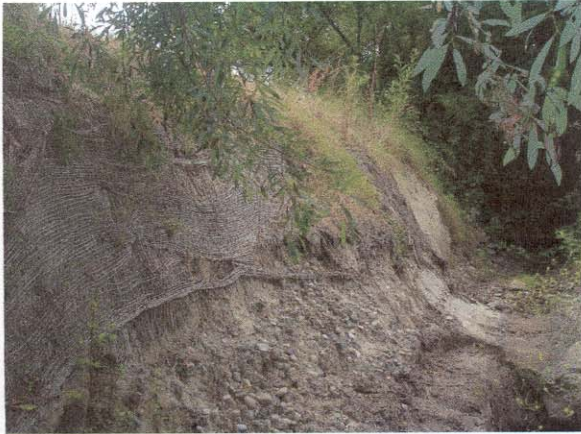
Picture 2

#5 The upland (Picture 2 and 4) is contributing sand and gravel, although the system seems to be handling it for now

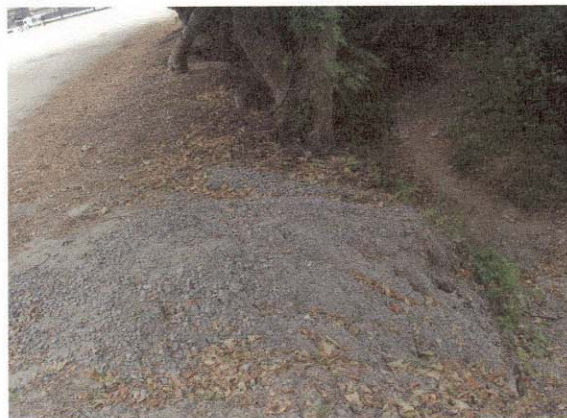
Picture 4

There is a pile of concrete mix, gravel and mulch sitting on the bank that is sliding into the creek bed (See Picture 4). The rest of the creek bed has a cobble composition perfect for spawning grounds.

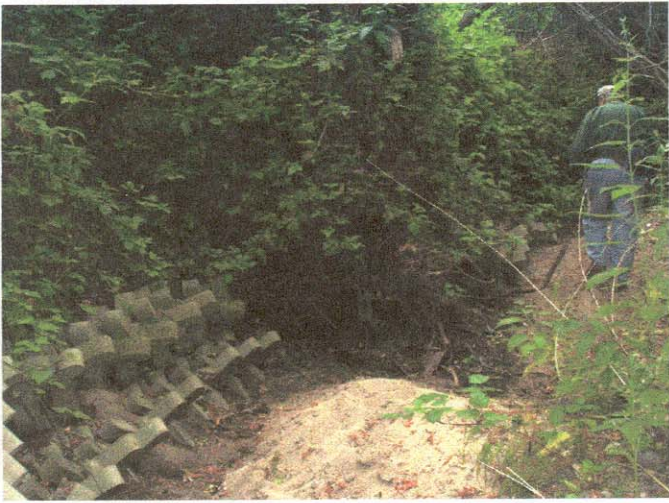
Picture 5

The ground and banks around the "dragon's teeth" structures are starting to erode (See Pictures 5 and 6).
