Standard Checklist

Name of Riparian-Wetland Area: Conejo Creek

Date: July 21, 2004 Segment/Reach ID: Reach 3 PFC 151

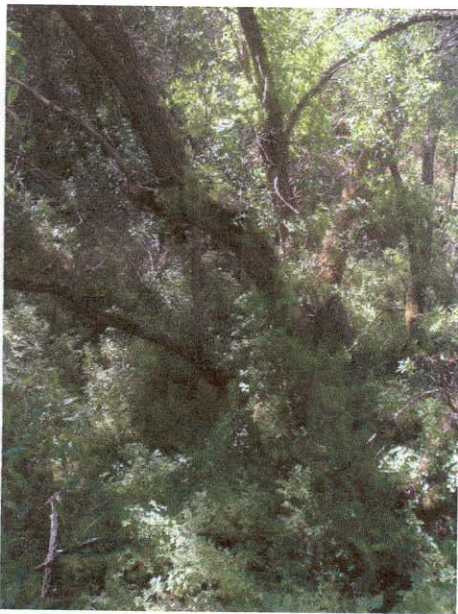
Picture 1

This reach begins near the residences off of Tassajara Rd. at GPS N 36,23.694 W121, 34.780 and ends at the confluence with the Cachagua creek. Most of this reach was assessed from the Tassajara Rd. as it was too overgrown and the banks were too steep to navigate the creek, the creek bed was observed first hand wherever possible (See Picture 1). This creek is very incised.

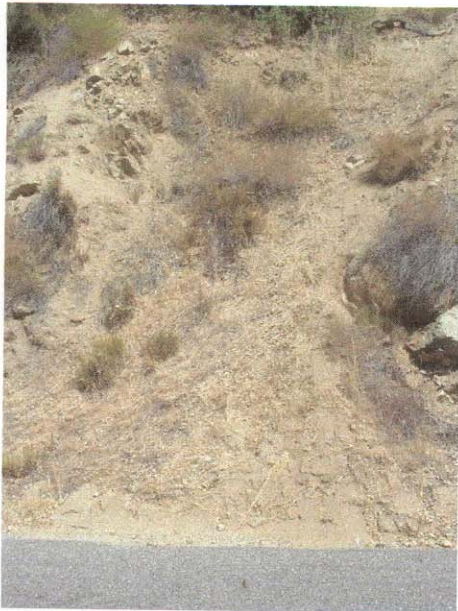
Picture 2

The upland hillsides by the road are severely eroding in several places with much of the sediment eroded pushed to the creek side of the road (See Pictures 2, 3 and 4). The creek bed in this reach has so much sediment that the bed is covered in several inches of mud and no cobbles or rocks are visible.

#5, 17 The uplands are eroding severely where the road cut occurred and much of the excess sediment on the road has been pushed into the ravine along the creek. There is excessive erosion and deposition observed in the creek. This creek runs directly into the Cachagua creek so the eroding uplands are very likely major sediment contributors to the Cachagua Creek.

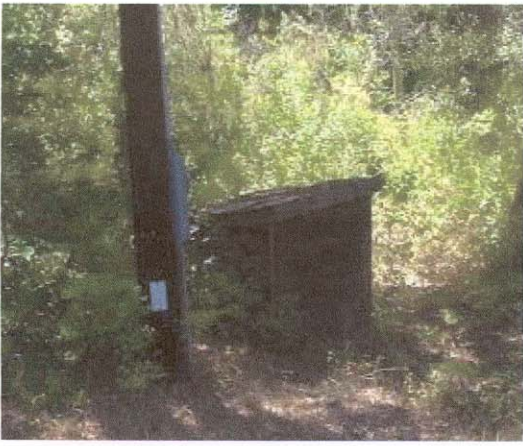
Picture 5

One pump and well are at GPS N 36,23.54 W 121,35.49 (See Picture 5).

#8, 10 There were some stressed alders and buckeyes near a well and pump.

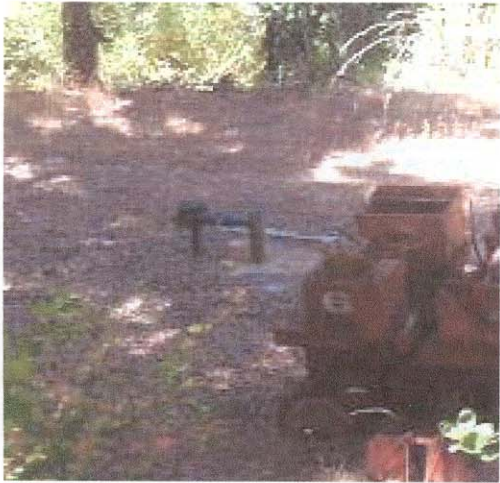
Picture 6

Another pump was at GPS N 36, 23.64 W 121, 35.17 (See Picture 6)

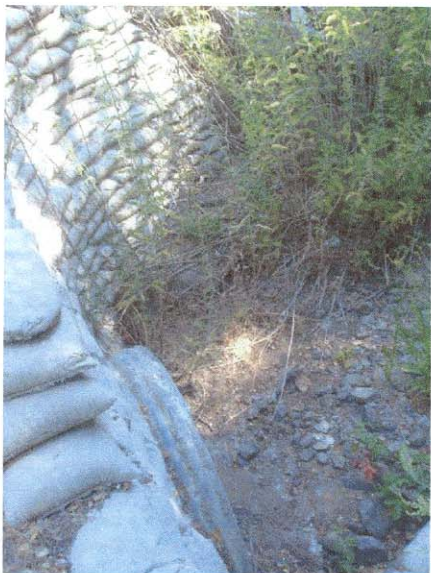
Picture 7

There are three culverts leading under the road and two pumps in this reach (See Pictures 5,6 and 7).
