## Standard Checklist

Name of Riparian-Wetland Area: Robinson Canyon Creek

Date: June 28, 2004 Segment/Reach ID: Reach 6 PFC 205

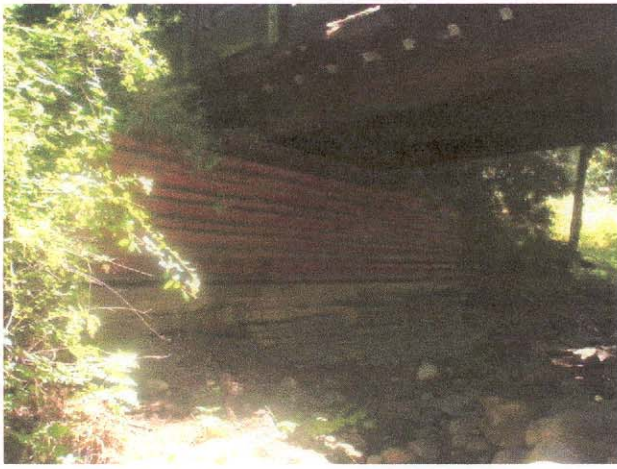
Picture 1

There was excessive undercutting and deposition in the reach. Bridge 509 is continuing to be severely undercut despite numerous past efforts to stabilize it. Past efforts have used 'crete' bags, concrete and a metal retaining wall (See Pictures 1 and 2). A private bridge in the creek is eroding, currently the sandbags seem to be helping to stabilize the bank (See Picture 3).
