Standard Checklist

Name of Riparian-Wetland Area: Robinson Canyon Creek

Date: June 28, 2004 Segment/Reach ID: Reach 4 PFC 207 _____

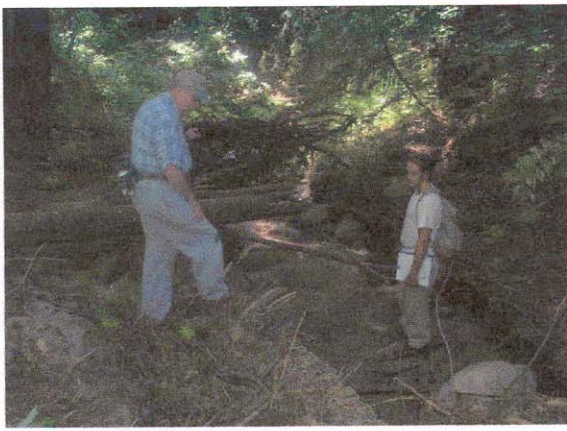
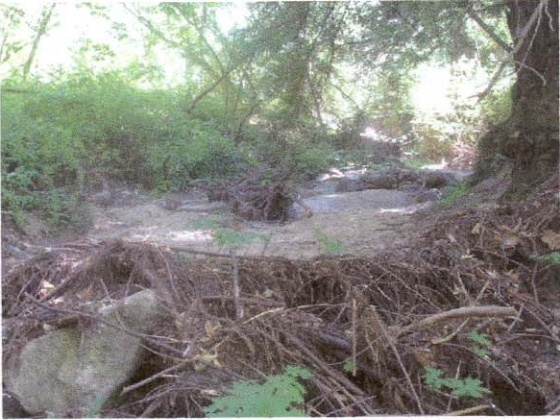
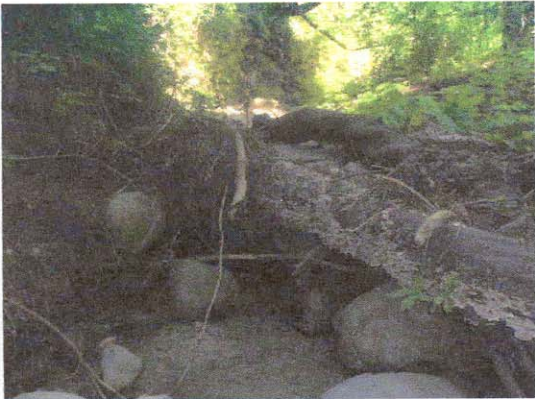
There is an excess of sediment throughout the reach, and several log jams that require clearing (See Pictures 1, 2, and 3). And a push of construction waste by house 28650 (See Picture 4).
