Standard Checklist

Name of Riparian-Wetland Area: Hitchcock Creek

Date: May 26, 2004 Segment/Reach ID: Reach 8, After Bridge 513 PFC 308

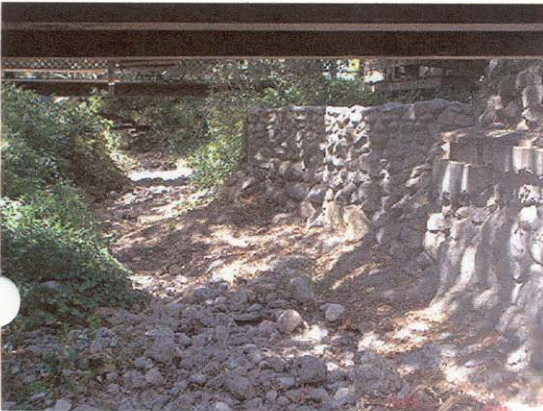
Picture 1

There are several buttressed walls that seem to be stable although one that lays at angle is becoming undercut (See Pictures 1 and 3).

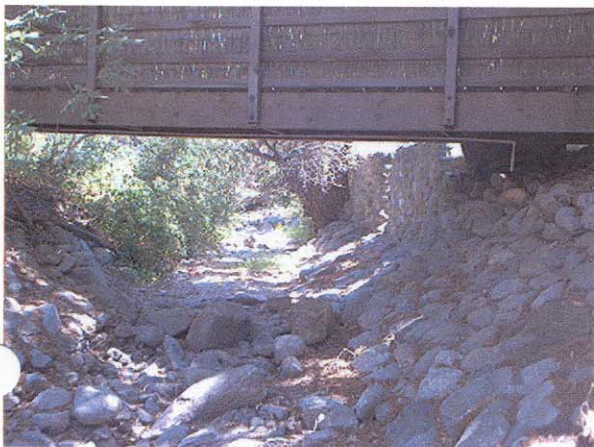
Picture 2

There are three large eroding and headcut hillsides that may be contributing to the large sediment piles found throughout the reach and on either side of Bridge 513 (See Pictures 2 and 4). The creek is also undercutting these three hillsides and exposing roots.

#5, 17 The eroding hillsides are contributing sediment and an excess of sediment has been found throughout the creek.
