Standard Checklist

Name of Riparian-Wetland Area: Hitchcock Creek

Segment/Reach ID: Reach 10

PFC 310

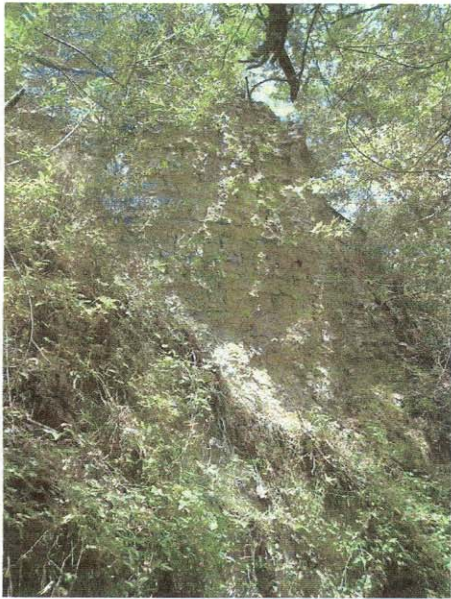
There are two upland hillsides that are eroding and contributing sediment to the reach but there is no excessive deposition (See Picture 1 and 2) . There is evidence of some erosion throughout the creek bed where tree and vine roots have been partially exposed.

#5 The upland watershed is eroding at two spots and contributing sediment and there is an excess of sediment throughout the creek.

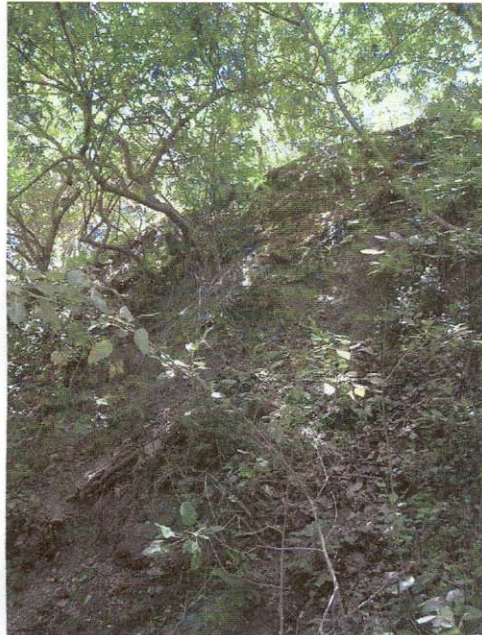
Picture 2

Yard waste has been dumped in three different sites in the creek (See Picture 2- yard debris).

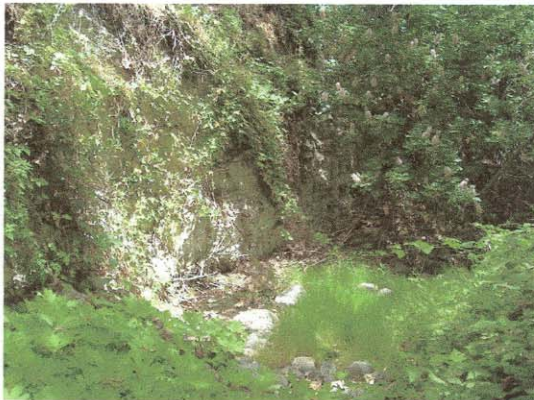
Picture 3

The vegetation is diverse in both age- class and composition. The area is wet from seepage and has a lot of algae growing in the creek bed (See Picture 3).
