## Standard Checklist

Name of Riparian-Wetland Area: Hitchcock Creek

Date: May 27, 2004 Segment/Reach ID: Reach 12, Bridge 518 PFC 312

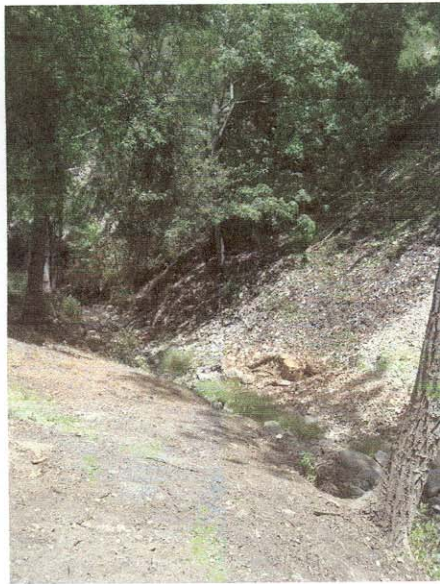
Picture 1

The eroding hillside by the house was worsened by a previous tree clearing which the owner has ineffectively tried to stabilize with wire fencing (See Picture 1). The lack of vegetation on both banks causes the system's inability to adequately dissipate the immense flow energy caused by the creek bottleneck prior to bridge 518.

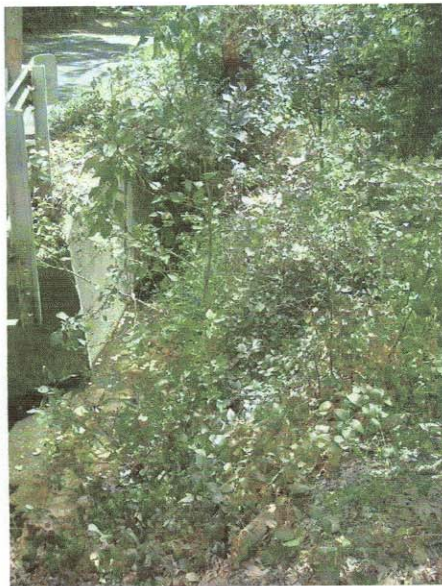
Picture 2

Bridge 518 is causing a great deal of erosion both directly upstream and downstream. The bridge makes the creek turn almost 90 degrees directly prior to passing under the bridge which is only 7 ft. wide, causing overflowing water to deteriorate the bank at the turn and carry sediment over the top of the bridge (See Picture 2). On the other side of the bridge is another sharp creek turn, which causes a severe undercut of two trees and a steep hillside (See Pictures 3 and 4). It seems this sharp turn doesn't help dissipate flow energy, and the sheer force it produces continues to degrade the already unstable hillside for the next 50-75 yds.

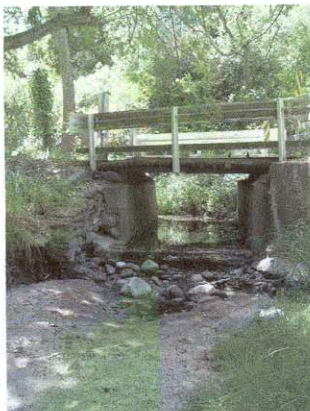
There is a lot of sediment deposition under or by the eroding hillside and bends (See Picture 3 and 4).

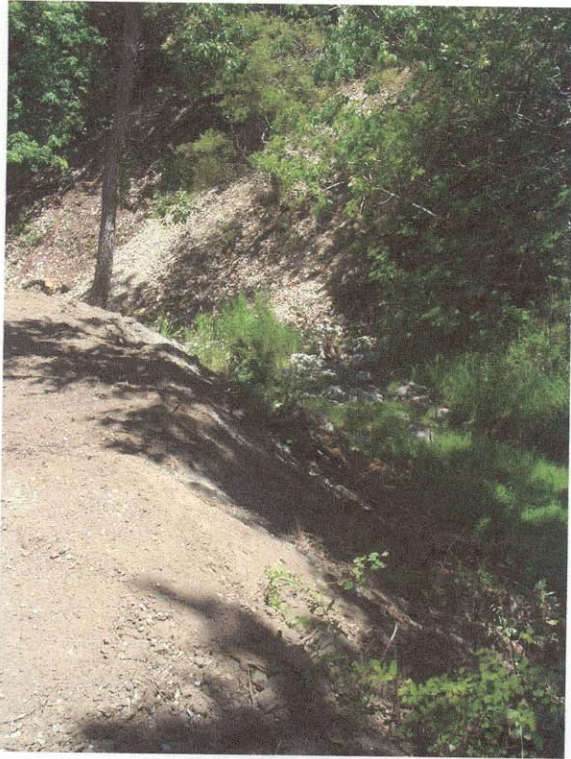
Picture 6

On June 15 while on route to complete other PFCs, it was observed that more dirt has been added to the site and has been pushed into the creek (See Pictures 6 and 7). The area is completely devoid of vegetation and the road side fence has been removed.
