Standard Checklist

Name of Riparian-Wetland Area: Hitchcock Creek

Date: June 7, 2004 Segment/Reach ID: Reach 15, (After Bridge 519) PFC 315

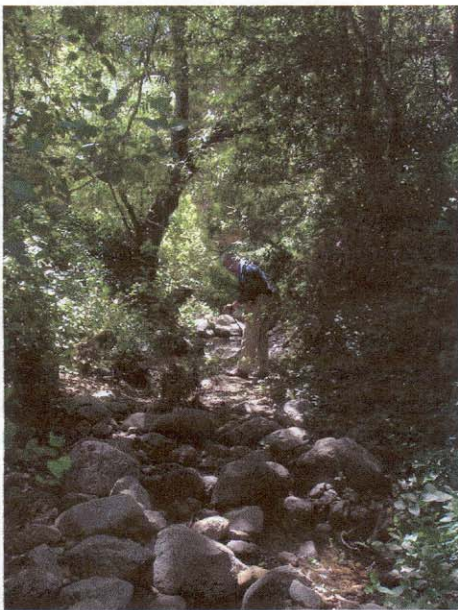
Picture 1

This reach is at the end of the urban setting, therefore it has proper vegetation throughout most of the reach (See Picture 1). There is some undercutting and erosion on the downstream right bank, but it looks natural and not severe.

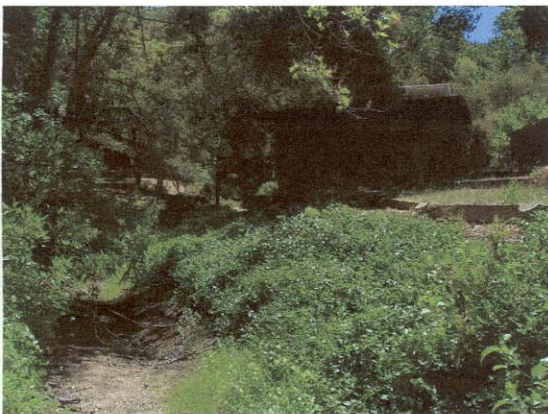
Picture 2

There is one house downstream of the bridge that has a terraced lawn and a cleared area presumably for a garden but as yet is devoid of vegetation with piles of soft dirt, some of which is falling into the creek (See Picture 2).

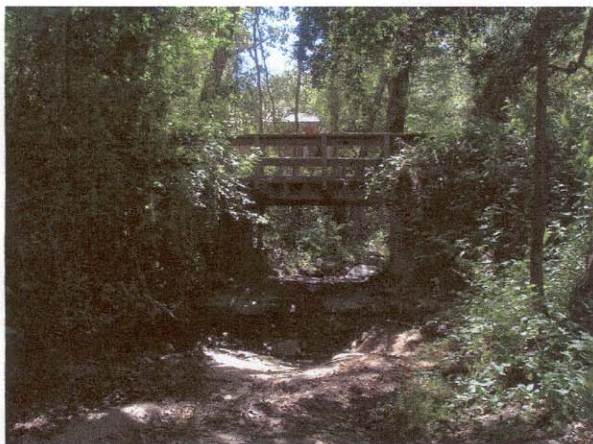
Picture 3

There are two areas of concern that make this reach at risk. There is a private bridge leading to four houses (66, 64 and two others unidentified) that is severely undercut, with a large pool downstream of it, followed by an enormous sediment pile (See Picture 3). This undercut bridge and pool are a fish migration impairment.

#5, 17 There is an excess of sediment throughout the creek. The system is not in balance, evident of the erosion and large sediment dump by the private bridge.

#16 The system is not vertically stable at the bridge where there is undercutting both under the bridge and on the inside corners of the base of the bridge.
