Standard Checklist

Name of Riparian-Wetland Area: Hitchcock Creek

Date: June 7, 2004 Segment/Reach ID: Reach 16 - end of county road and up

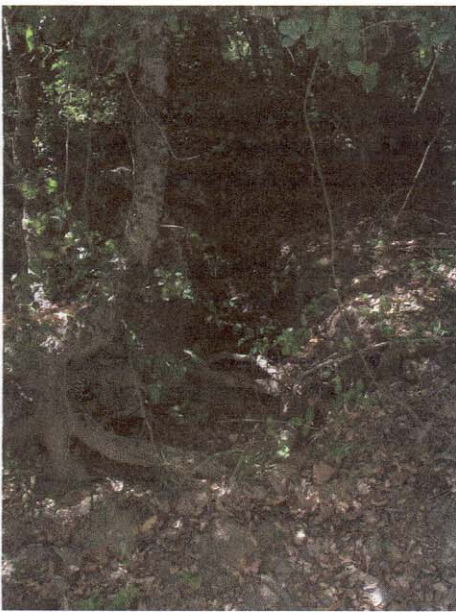
Picture 1

On the upland road side of the creek there is an incision that leads up to the road and continues uphill on the other side of the road (See Pictures 1 and 2). There are piles of sediment in front of the incision, along the street for several hundred yards and excessive piles of sediment throughout the reach which grow larger as they near the source.
