Standard Checklist

Name of Riparian-Wetland Area: Hitchcock Creek

Date: June 15, 2004 Segment/Reach ID: Reach 20 PFC 320

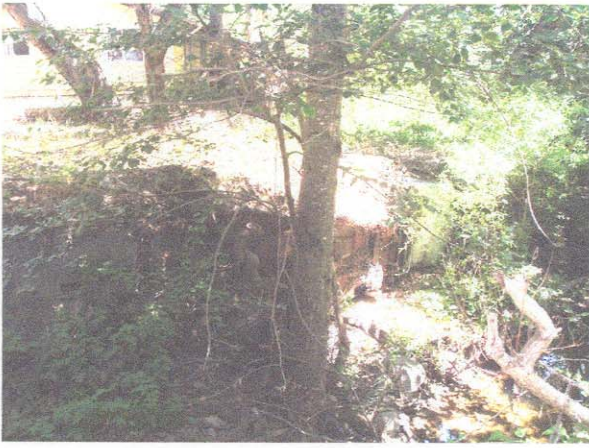
Picture 1

The west bank is armored with a truck on its side and various other scrap metals. This is all covered with a wire fencing, however the truck is becoming undercut and some of the metal parts have already been pulled downstream (See Picture 1). Further up on the left bank there is a back hoe, a large clearing and fresh dirt piles 6-10 ft. high (See Picture 3). There is one dirt pile about 6 ft. high directly on the bank and starting to fall in.

#3, 15 The sinuosity is naturally trying to move westward but the armored bank is preventing that for the time being.

#16 The system is not vertically stable for much longer where it is armored with the truck parts.

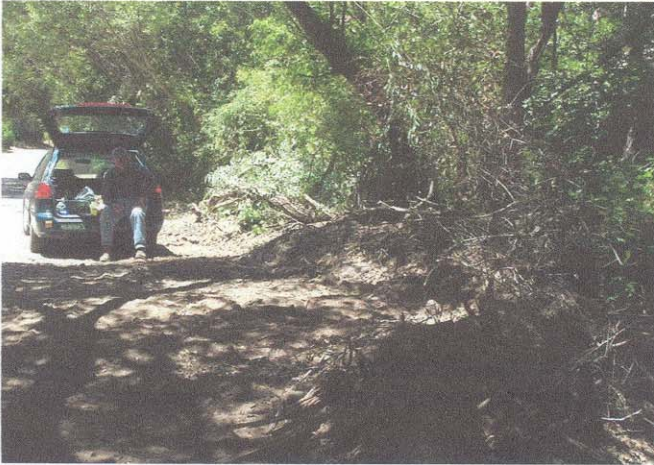
Picture 2

There is also half of a large willow laying on the side of the road- apparently broken off, not sawed (See Picture 2).
