Standard Checklist

Name of Riparian-Wetland Area: Cachagua Creek

Date: July 20, 2004 Segment/Reach ID: Reach 12 PFC 404

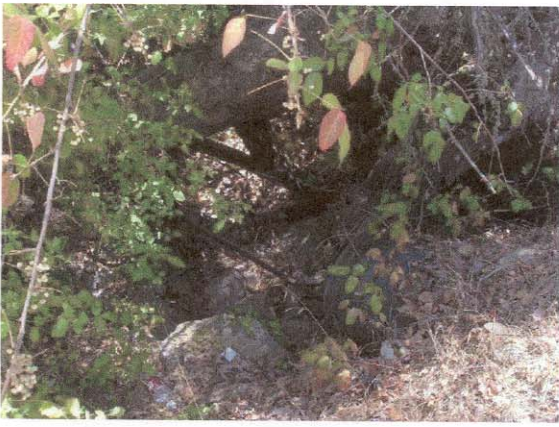
There are two tributary creeks observed at GPS N 36,23.55 W 121,38.37 and GPS N36, 23.53 W121, 38.35- the second tributary listed had a severely blocked culvert (See Picture 3). The first tributary's sandbags and culvert were eroding (See Picture 1 and 2).

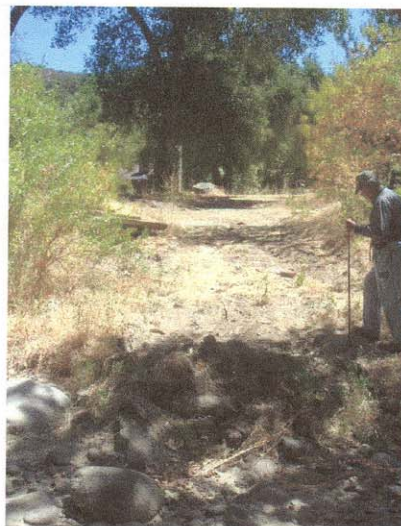
Picture 4

There is dirt pushed into the creek early in the reach (See Picture 4).

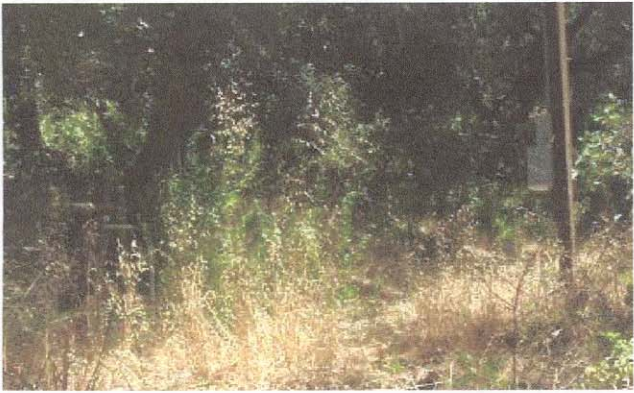
Picture 5

There are three wells in this reach (See Picture 5).

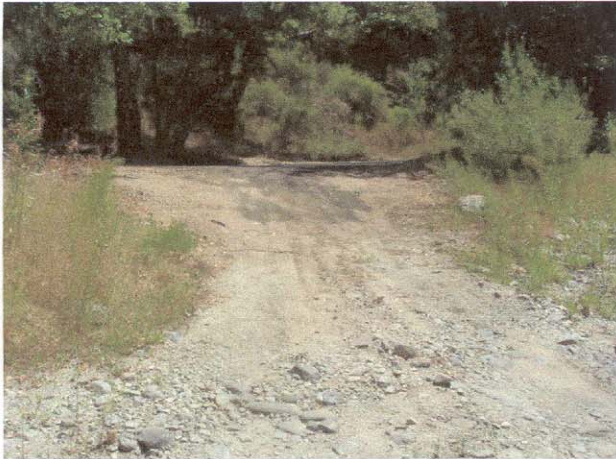
Picture 6

There is a dirt ford next to a paved road and bridge, near another upland road cut (See Picture 6). There are several large sediment deposits in this area, along with predominantly upland species near the wells (See Picture 7). There was a lack of smaller riparian plants throughout this reach.

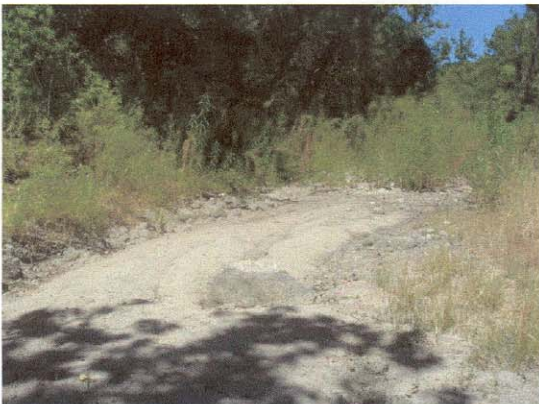
Picture 7

#5,17 There is excessive sediment in this reach including several large deposits.
