Standard Checklist

Name of Riparian-Wetland Area: Cachagua Creek

Date: July 13, 2004 Segment/Reach ID: Reach 10 PFC 406

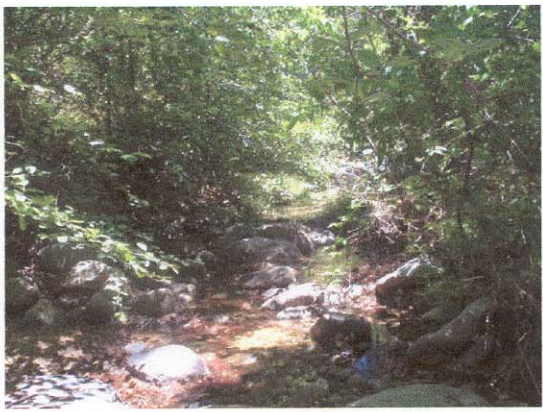
Picture 1

There are healthy alders in the creek, however, there are many dead alders ten feet up the bank (See Picture 1- for healthy conditions).

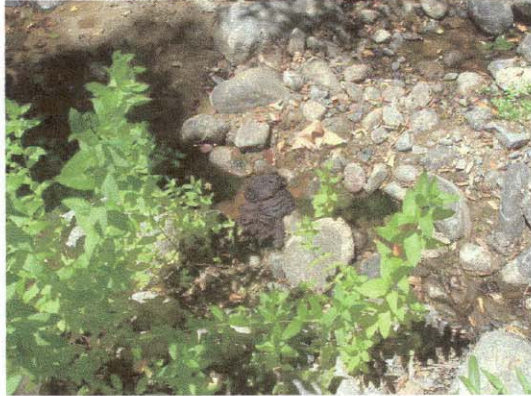
Picture 2

Cattle manure abounds as do algal blooms in the creek bed (See Picture 2).

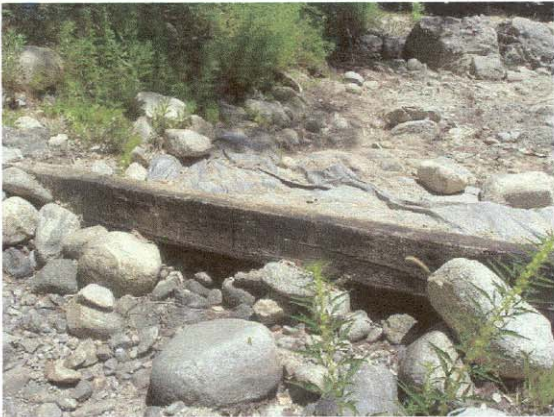
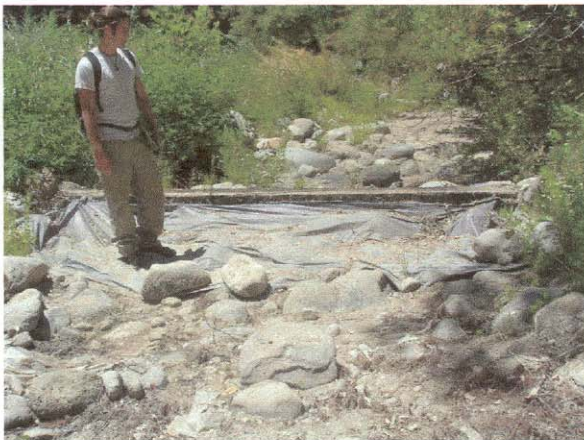
There are two wooden summer dams downstream from the cattle trails (See Pictures 3 and 4).

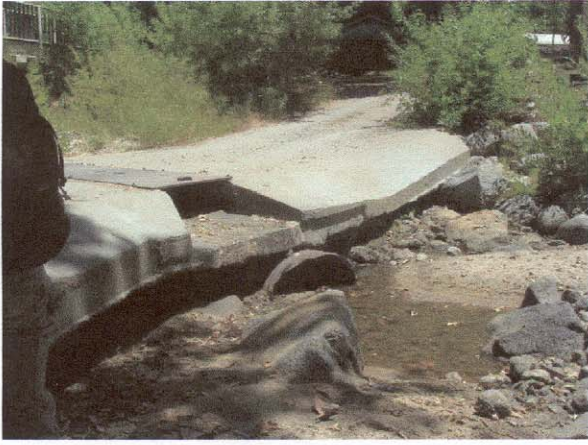
Picture 5

There is an undercut footbridge followed by a concrete ford with a removable metal culvert. This ford was constructed over an old defunct metal culvert that had filled with sediment. This whole structure is now severely undercut and is a severe impediment to migrating fish (See Picture 5).

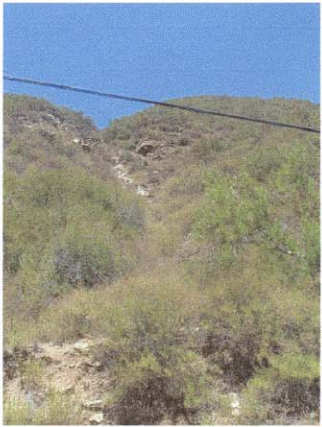
Picture 6

Upland erosion was observed above the road on the North bank (See Picture 6).

#16 There is excessive erosion on the hillsides above the county road on the north bank, and where cattle trails have been established. (Observed near power pole 144 on Cachagua Road)
