Standard Checklist

Name of Riparian-Wetland Area: Cachagua Creek

Date: July 12, 2004

Segment/Reach ID: 8

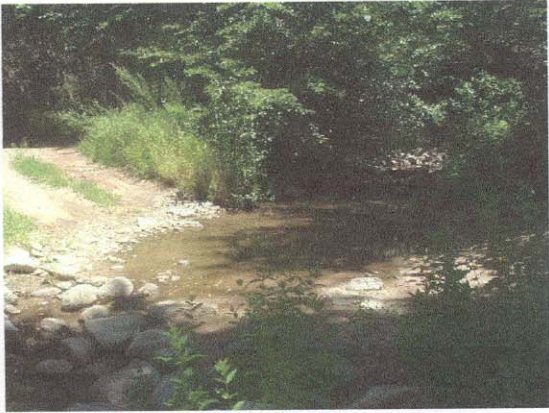
Picture 1

There is a dirt ford across the creek immediately following the wooden footbridge (see picture 1).

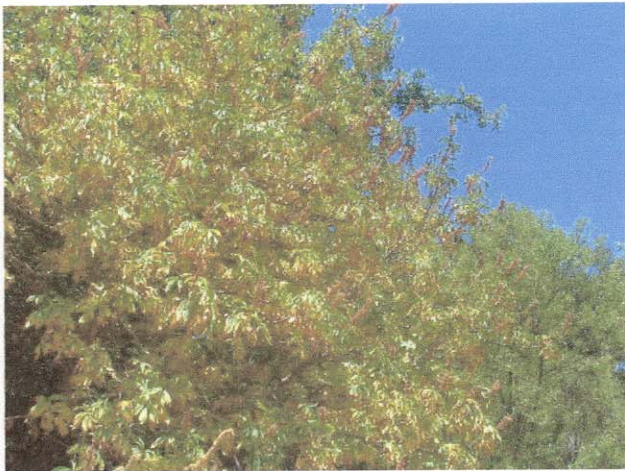
Picture 2

Although most of the vegetation is diverse in composition and age-class, there is one stretch lacking riparian-wetland species. The few riparian-wetland species in this particular area (such as buckeyes) do not exhibit high vigor (see picture 2).

#8,10 There is an arid stretch with yellowing buckeyes and a predominance of upland species that exhibits all the normal characteristics of de-watering (picture 2).
