## Standard Checklist

Name of Riparian-Wetland Area: Cachagua Creek

Date: July 9, 2004 Segment/Reach ID: Reach 3 PFC 413

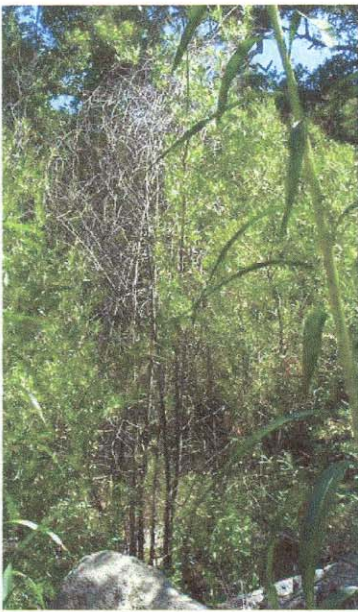
Picture 1

There are only a few willows present in the beginning of the reach. However, throughout most of the reach the wetland vegetation is very sparse and minimally diverse in its age class and composition, while the upland species predominate the area. A few sycamores and madrones were observed as well as dead alders (See Picture 1).

#10 There were dead alders, and the absence of willows and other riparian plants were indicative of a lack of water.

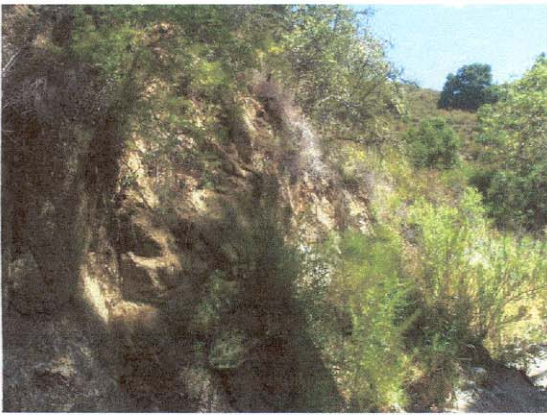
Picture 2

There are quite a few instances where a lot of decomposed granite is eroding into the creek (See Picture 2). There were also several sites of bank erosion (See Picture 3).

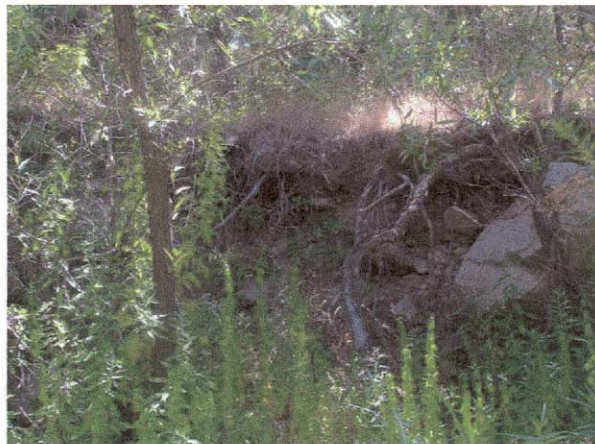
Picture 3

#16 It should be noted that there was some bank erosion and decomposed granite eroding into the creek.

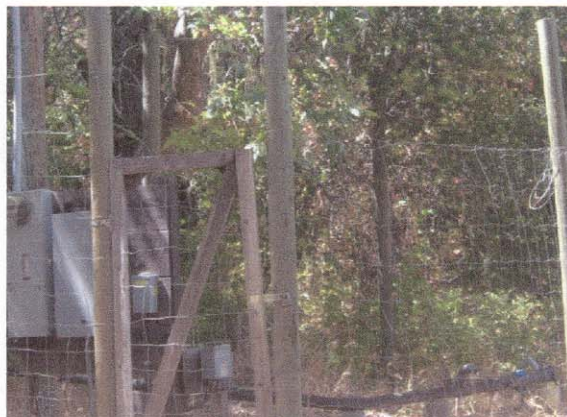
Picture 4

A pump was observed on the south bank towards the end of the reach (See Picture 4). Just downstream of the pump, there are the remnants of two old concrete structures on the banks with some of the rubble and metal wires embedded into the creek bed, which need to be removed (See Pictures 4, 5, 6 and 7).
