Standard Checklist

Name of Riparian-Wetland Area: James Creek _____

PFC 503

Date: July 5, 2004 _____ Segment/Reach ID: Reach 2 _____

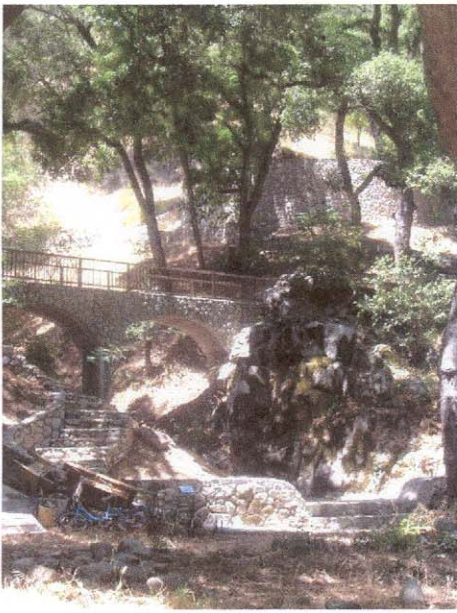
Picture 1

Workers from residence 38670 were seen extracting large cobbles from the creek apparently for construction use on their expansive rock walls, bridge, stairway, and patios (See Pictures 1 and 2).

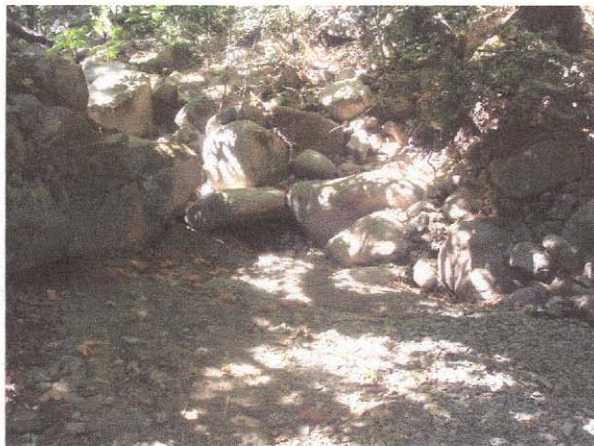
Picture 3

There are some sediment deposits throughout the reach however, cobbles are still visible (See Picture 3).

#5, 17 There are some sediment deposits in this reach, however they do not appear to be excessive as cobbles are still visible.

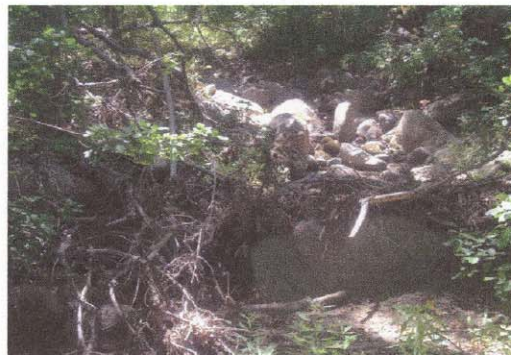
Picture 4

There is one logjam in the area (See Picture 4).
