Standard Checklist

Name of Riparian-Wetland Area: San Clemente Creek

Date: June 3, 2004 Segment/Reach ID: Reach 1, Confluence with dam PFC 601

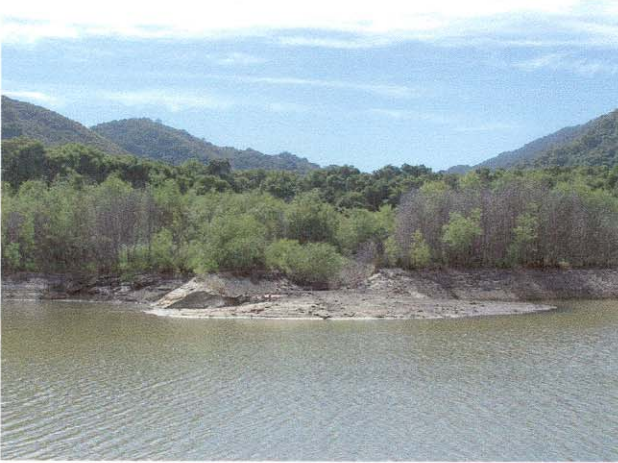
Picture 1

At the confluence with the reservoir, there are barren sandbars, a few dead bushes and a dozen dying Alders resulting from the dam draw down of 10 feet (See Picture 1).
