Standard Checklist

Name of Riparian-Wetland Area: San Clemente Creek (San Clemente Rancho)

Date: May 20, 2004 Segment/Reach ID: Reach 7, #2 Jake's Cabin PFC 607

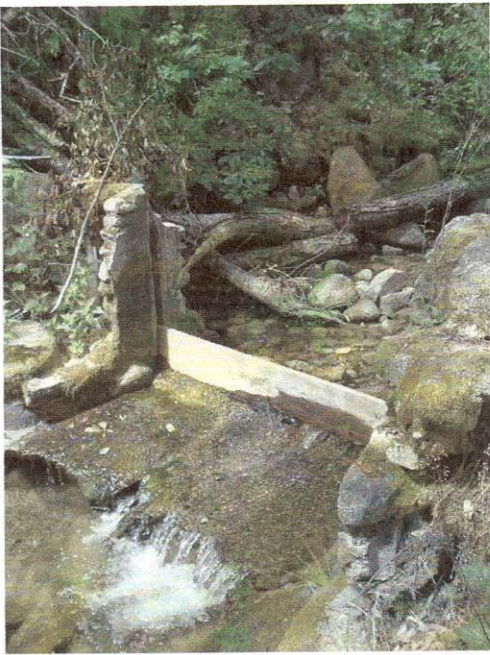
The old summer dam is undercut. In low water it is a fish impairment.
(See Picture 1 and 3).

There is an excess of sediment in the pool at the base of the dam.
