Standard Checklist

Name of Riparian-Wetland Area: San Clemente Creek - (RSCP) PFC 608

Date: May 18, 2004 Segment/Reach ID: Reach #1- Creek Trail Bridge

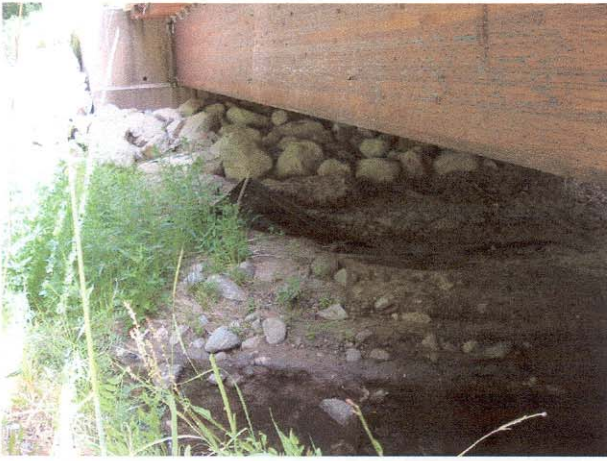
Picture 1

The attempts to control and stabilize the excess sediment from flowing into the creek with plastic stabilizers have been futile. Two examples of these washed out plastic stabilizers were observed (See Picture 1). The remnant fence posts of another stabilization attempt were also observed in the creek bed.

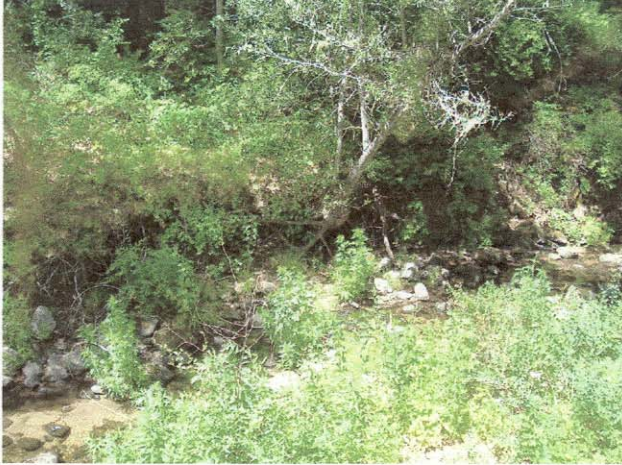
Picture 2

Both the creek and the upland sides of the 2 roads parallel to the creek are eroding, and attempts have been made to stabilize them with vegetative matting and grasses (See Pictures 2, 3, and 7). There is a variety of vegetation that will provide new recruits and many grasses have been planted, however, not enough time has passed for these to mature and stabilize the bank and road sides.

There are undercut trees in the creek bed that are in danger of falling into the creek and taking part of the banks with them (See Pictures 2 and 3).

#9 The mature trees have stable root systems for now, but they are being undercut and therefore would probably not withstand a high flow (See Picture 2, 3 and 5).

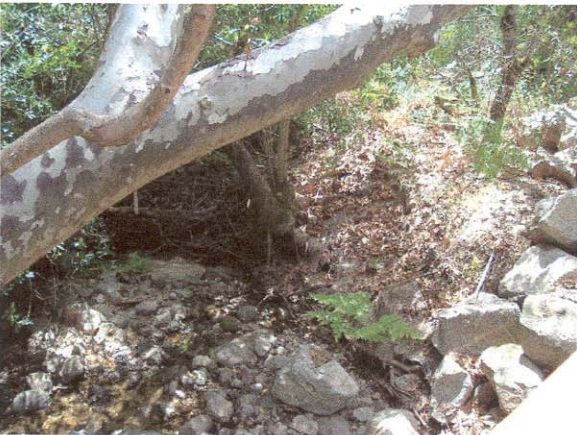
Picture 4

There is a lot of debris accumulating on the banks (See Picture 4).

#11 The plants in their current state would not withstand a high flow, however, measures have already been taken to try to correct this by planting grasses and encouraging new recruits (See Picture 4).

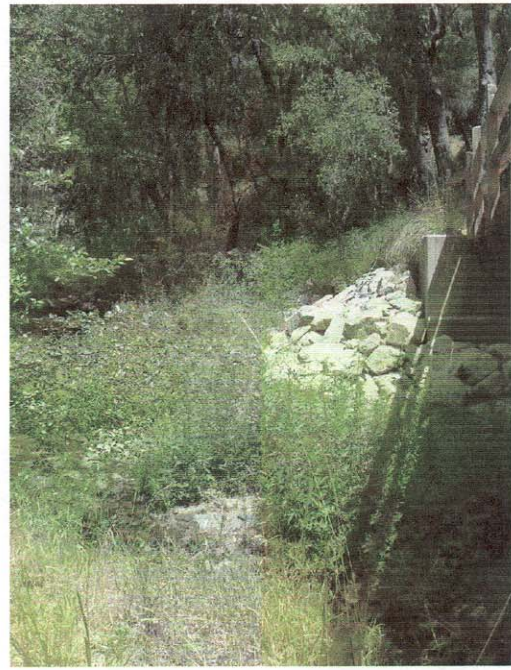
Picture 6

This area has been seriously degraded by previous road and bridge construction, and many steps have been taken to try to correct it. There is a lot of bank erosion and sediment deposition in the creek, especially around the bridge bases. The bridge has at least 20 large boulders protecting both sides of its left and right bases from erosion (See Pictures 6 and 7).
