Standard Checklist

Name of Riparian-Wetland Area: San Clemente Creek (RSCP) PFC 609

Date: May 18, 2004 Segment/Reach ID: Reach 2, Trail Bridge, Downstream

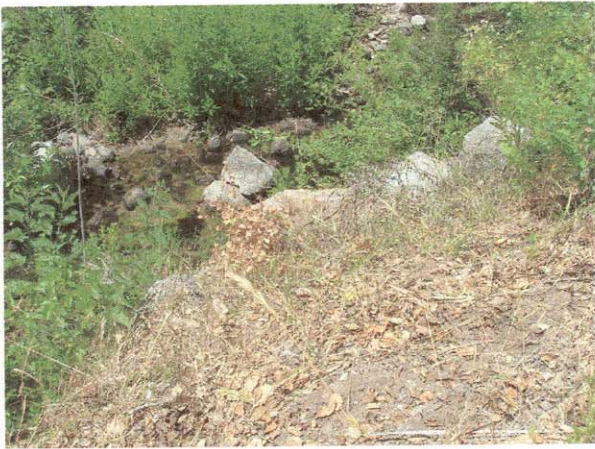
The bank slope next to the road is very steep, unvegetated and eroding. The bottom has been shored up with rocks while the top has been covered with a vegetative matting and seeded (See Picture 1 and 2).

#9, 11 The little bit of vegetation on the roadside bank is not capable of withstanding or dissipating a high stream flow event.

#16 The system is not vertically stable on the roadside bank or where undercutting is occurring.

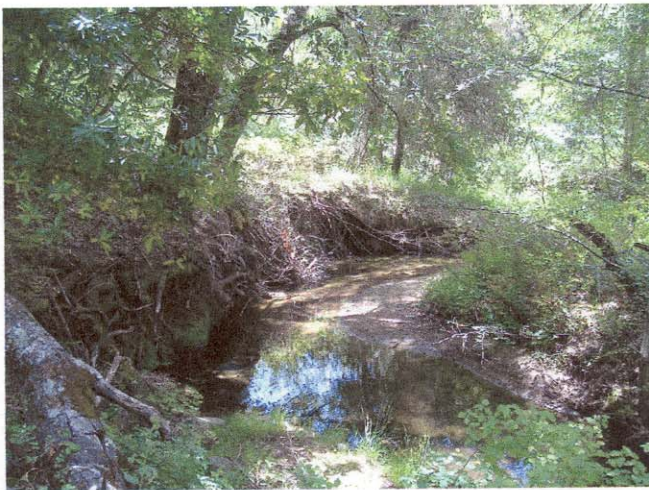
Picture 3

Further downstream the banks are being undercut, exposing large tree roots (See Picture 3).
