Standard Checklist

Name of Riparian-Wetland Area: Finch Creek

Date: August 9, 2004 Segment/Reach ID: Reach 13 PFC 702

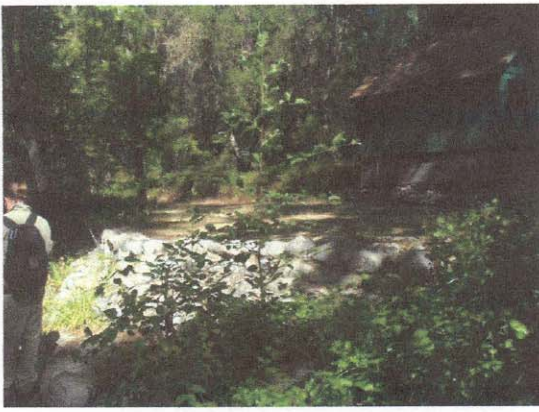
Picture 1

This reach begins at the beginning of a series of buttressed banks on the north side of the creek (See Picture 1).

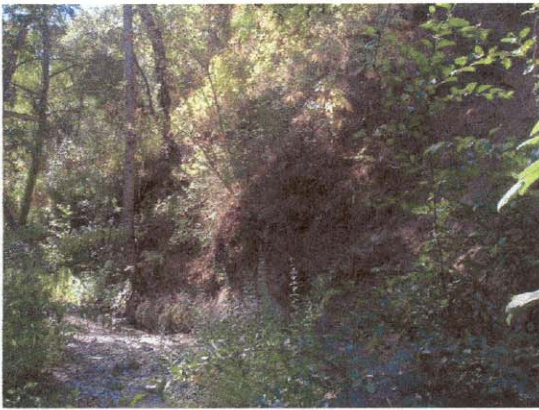
Picture 2

There are two eroding hillsides within this reach, one on each side of the creek (See Picture 2).

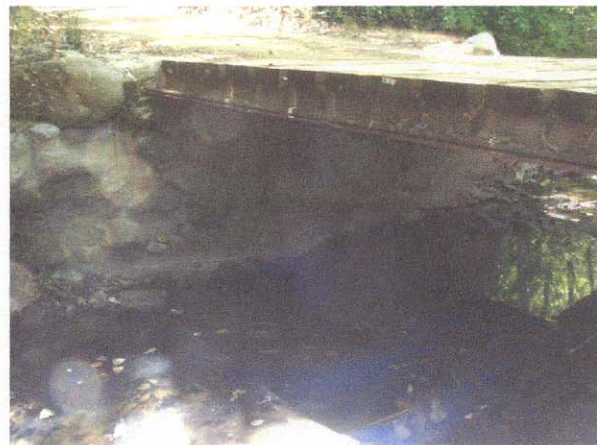
Picture 3

There is one wooden bridge that is becoming undercut (See Picture 3).

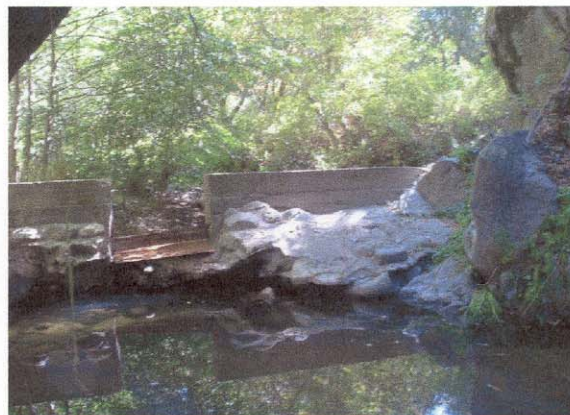
Picture 4

There is one large concrete summer dam with no culvert that is severely undercut and therefore is a fish impediment in low flows. There is a large PVC pipe protruding into the creek right above the dam, apparently used to extract water during higher flows (See Picture 4).

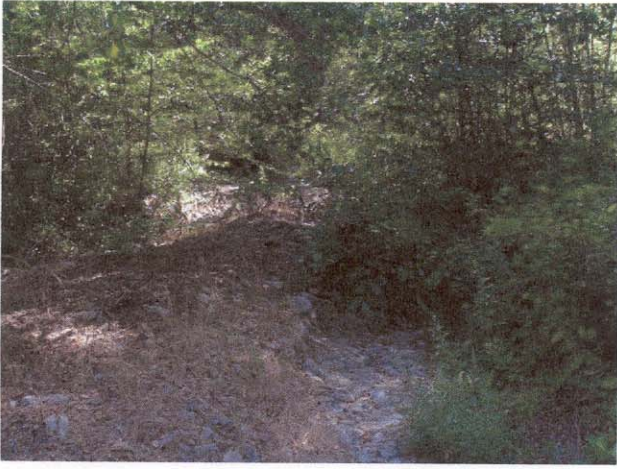
Picture 5

Vegetation is dense and vigorous throughout this reach, however a handful of dead alders were observed (See Picture 5-of dense vegetation).
