## Standard Checklist

Name of Riparian-Wetland Area: Finch Creek

Date: August 3, 2004 Segment/Reach ID: Reach 11 PFC 704

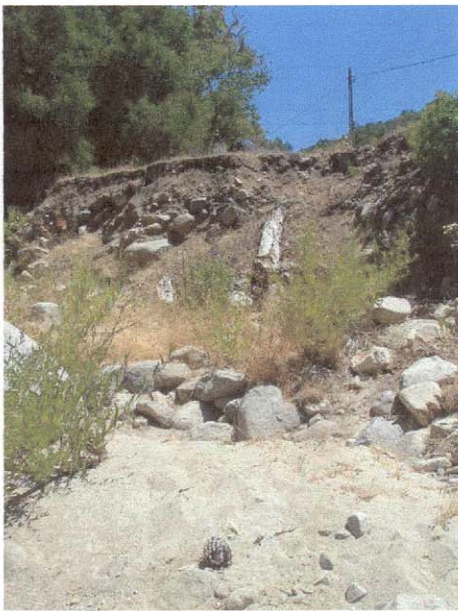
Picture 1

There is a large land slide on the roadside bank for a couple hundred feet (See Picture 1). There are several large sediment deposits and a few eroding hillsides along with several other dirt slides (See Picture 2).

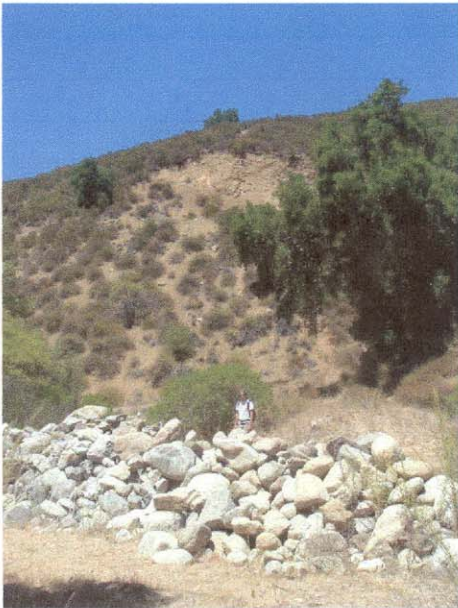
Behind two houses on Carmel Valley Road are four large piles of rocks (seemingly large river rocks) (See Picture 2 and 3), and several piles of house and construction waste near the creek (such as wood boards, oil barrels, etc.), (See Picture 7).

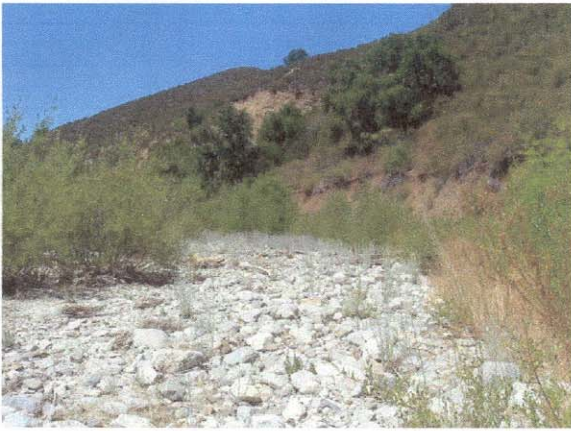
Picture 5

The riparian area is very narrow and predominated by upland species, the willows present are still small and most of the area is left unshaded. There is a large area that is a braided/floodplain (See Picture 5).

#3, 15 The creek forms a large braided area/ floodplain.

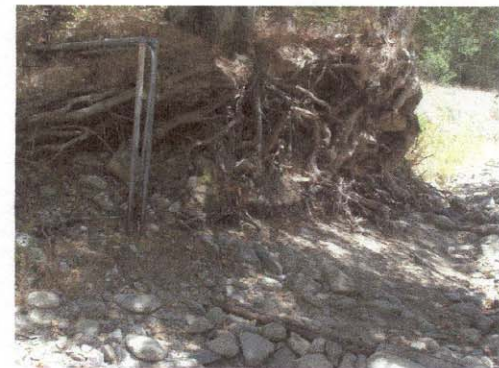
Picture 8

There are two pipes leading from the creek bed to the house (See Picture 8).
