Standard Checklist

Name of Riparian-Wetland Area: Finch Creek

Date: June 30, 2004 Segment/Reach ID: Reach 10 PFC 705

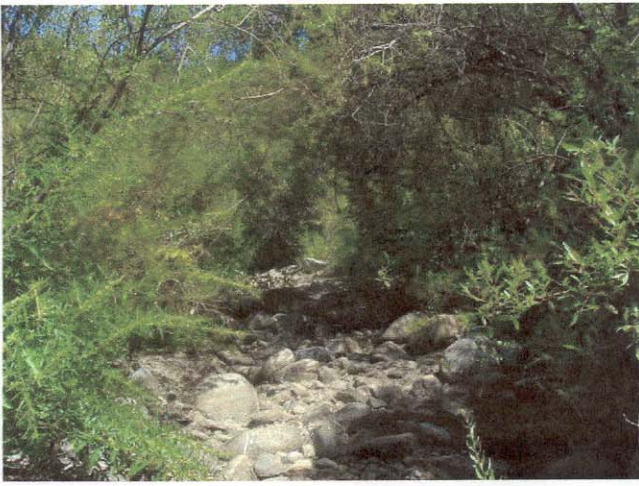
Picture 1

There is an abundance of vegetation diverse in both its age-class and composition. The creek is composed of large boulders, rocks cobbles and sand all in appropriate proportions (See Picture 1).

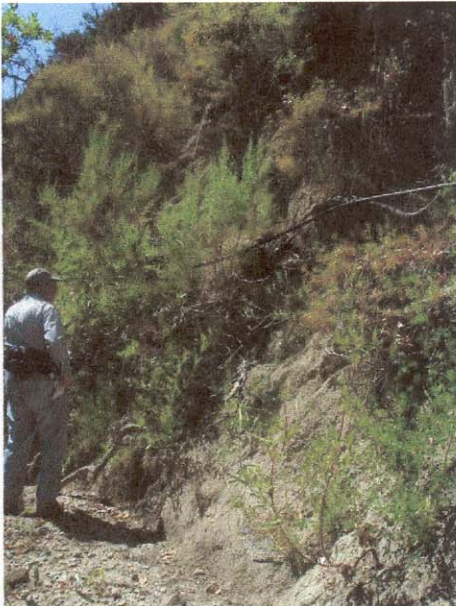
Picture 2

A hillside of crumbling decomposed granite is eroding into the creek, however, it does not seem to be degrading this reach (See Picture 2).

#5, 17 There was some excess sediment in this reach from the eroding hillside, however it does not seem to be severely degrading this particular reach.

#16 There is a large eroding hillside, however the rest of the system is stable.

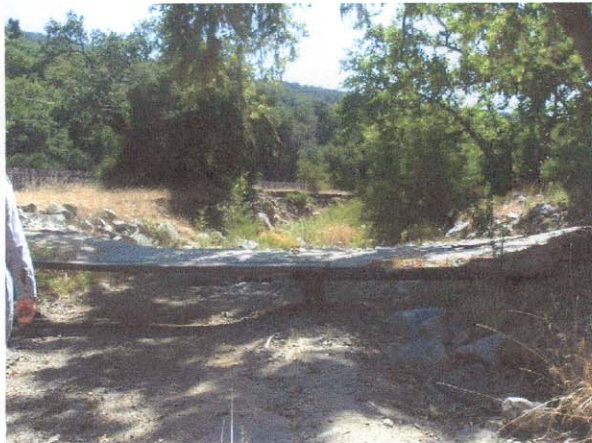
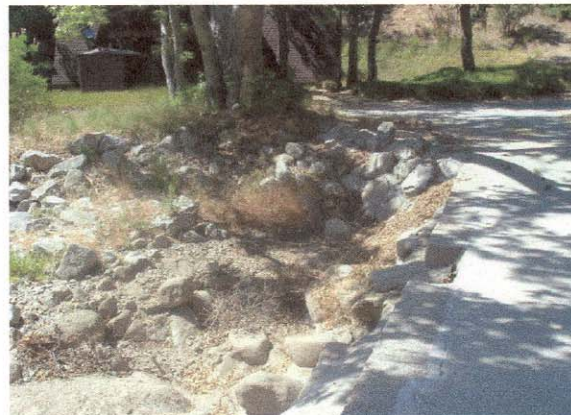
There is a large ford with concreted boulders to stabilize the banks and edges of the ford at the end of the reach. There are 3 six to eight inch culverts running under the ford and a large deep pool on the downstream side (See Pictures 3 and 4). The south bank on the downstream side is being undercut. In low flows this could be an impediment to fish migration.
