Standard Checklist

Name of Riparian-Wetland Area: Finch Creek

Date: August 3, 2004 Segment/Reach ID: Reach 8 PFC 707

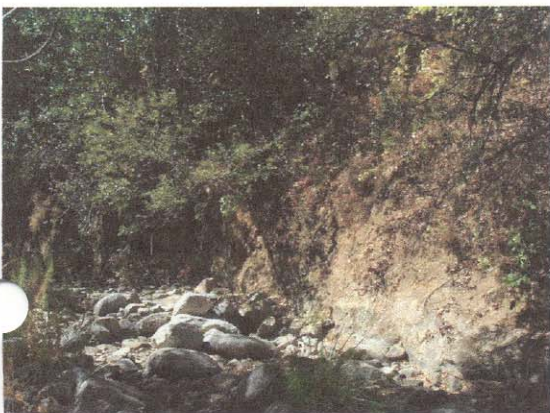
Picture 1

There are a lot of large mature trees creating a dense canopy and lots of shade (See Picture 1). There are only a few willow and alder recruits, along with several dead alders and dried up upland species.

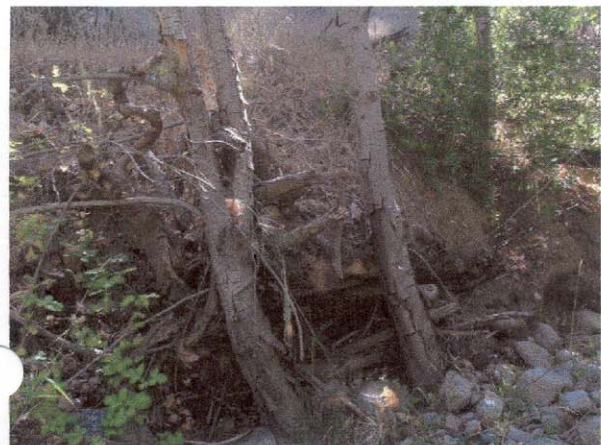
#16 There is some bank erosion and undercutting observed through the reach (See Picture 2 and 3).
