Standard Checklist

Name of Riparian-Wetland Area: Finch Creek

Date: August 2, 2004 Segment/Reach ID: Reach 6 PFC 709

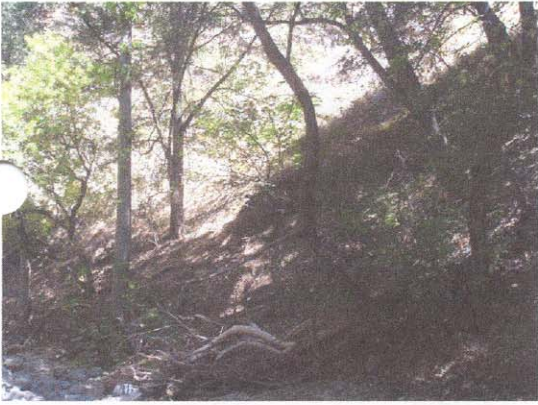
Picture 1

This reach contained a diversity of mature riparian wetland species, including alders, sycamores, maples, willows, buckeyes and bay laurels. Although many parts of the reach lacked adequate ground cover, and recruits were not abundant, there are plenty of young and mature trees to stabilize the banks (See picture 1).

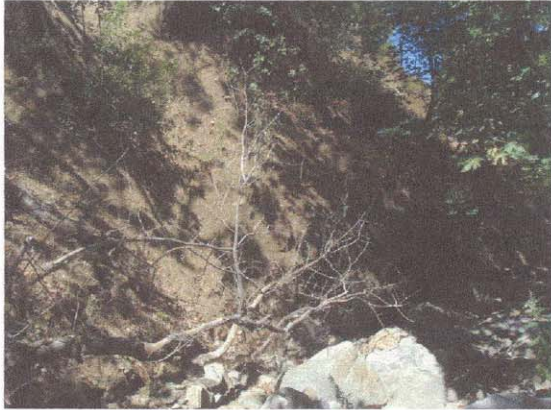
Picture 2

There are slides on the roadside bank both above and below the county road, however no excessive deposition is visible at this time (See pictures 2,3).

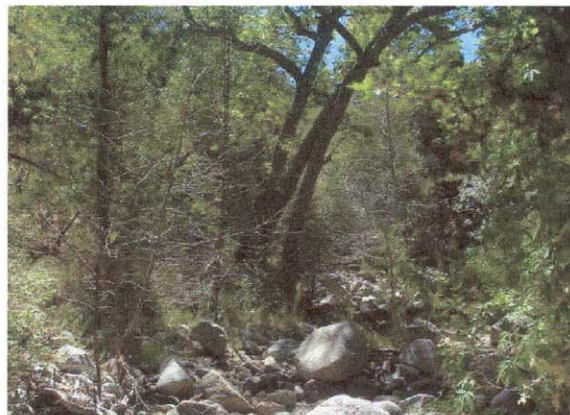
Picture 4

#8,10 There are a number of dead alders of varying ages in this reach (See picture 4).
