Standard Checklist

Name of Riparian-Wetland Area: Garzas Creek

Date: August 10, 2004 Segment/Reach ID: Reach 1 PFC 804

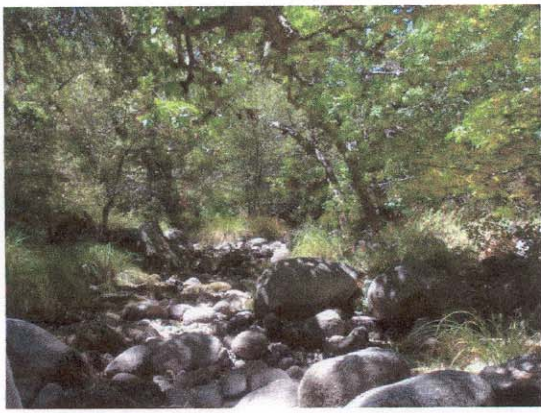
Picture 1

This reach begins halfway between the confluence of Moore's Lake with Garzas Creek and the end of the Redwood Creek Trail in Garland Park. The system was rated in PFC, as the vegetation is dense and diverse in both its composition and age-class. The creek bed is composed of an ideal mix of large boulders, cobbles, rocks and gravels (See Picture 1).

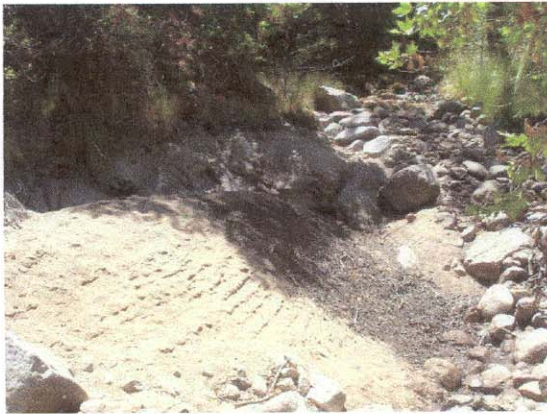
Picture 2

There was one site where a pool has been scoured out and a large sediment deposit has occurred, however the rest of the system showed no signs of excess sediment (See Picture 2).

GPS: N36,28.821 W121,46.224.

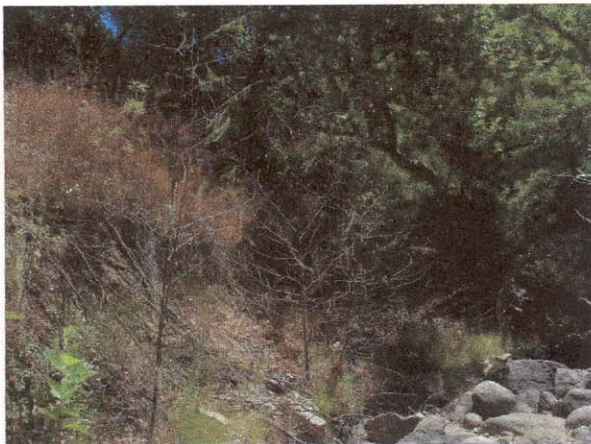
Picture 3

A half dozen dead alders were observed (See Picture 3).

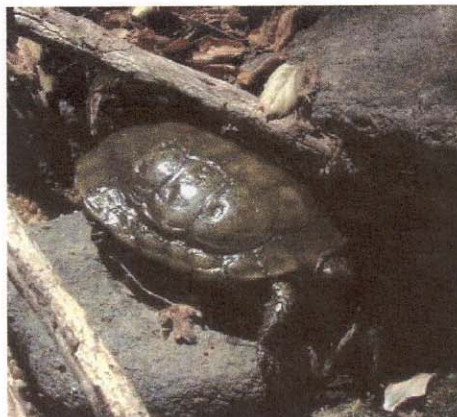
Picture 4

One pond turtle was observed (See Picture 4).
