Standard Checklist

Name of Riparian-Wetland Area: Tularcitos Creek

Date: September 2, 2004 Segment/Reach ID: Reach 4 PFC 902

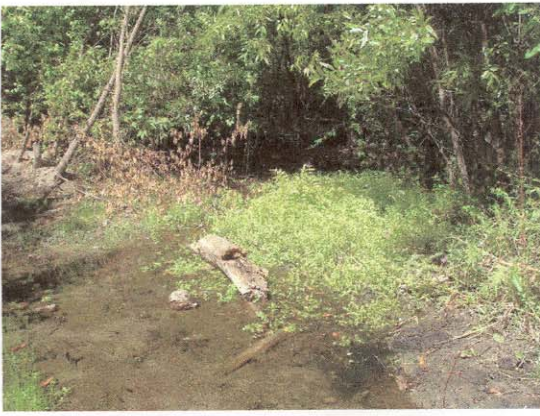
Picture 1

This reach begins where the road diverges from the creek. The very top was inaccessible due to very dense vegetation and tree limbs in the creek. The creek was walked from N36, 27.159 W121, 41.800, at this site is a pump and a functioning dirt ford that crosses the creek (See Pictures 1 and 2). There are some muddy areas, where excess sediment has been deposited, likely due to the very low gradient found in those areas.

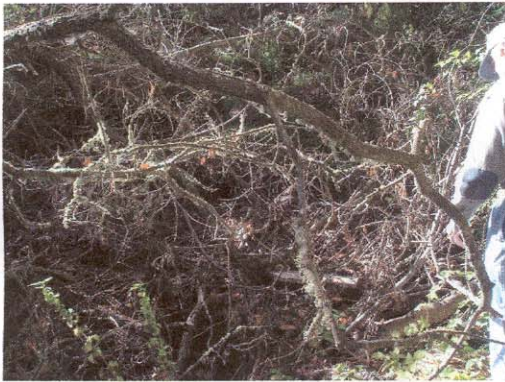
Picture 3

There was seepage found throughout the lower half of the reach and lush vegetation throughout. There is plenty of large woody debris throughout the creek and many instances of logjams that made the creek nearly impassable (See Picture 3). The creek banks have well rooted and vigorous vegetation. The creek beds and floodplains are composed of cobbles and gravels. (See Picture 4)

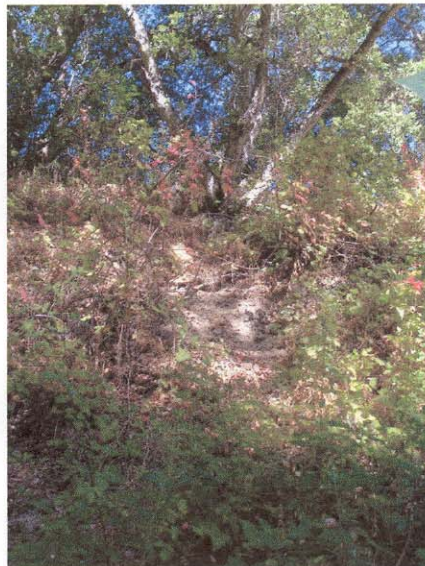
Picture 5

There is a small naturally occurring dirt slide (See Picture 5). There is a large dirt push that is falling down the steep hillside along Carmel Valley Road at GPS N36,27.444 W121,42.407.

#17 There are a few slides and some stretches that are very muddy, but overall the reach does not have an excess of sediment.
