Standard Checklist

Name of Riparian-Wetland Area: Tularcitos Creek

Date: August 11, 2004 Segment/Reach ID: Reach 3 PFC 903

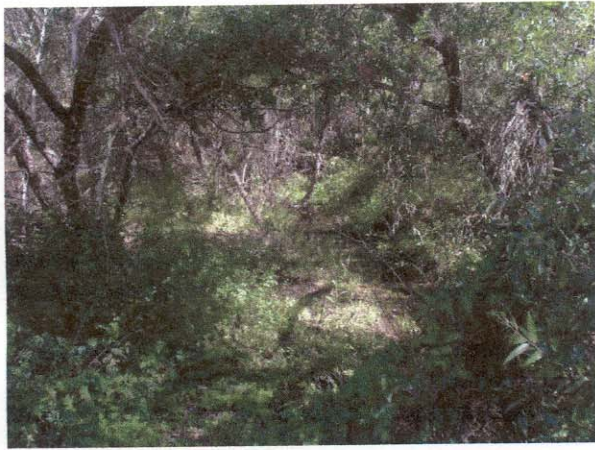
Picture 1

The vegetation is composed of dense vigorous willows and sycamores, alders with an abundance of grasses and vines. There were some recruits noted (See Pictures 1 and 2).
