Standard Checklist

Name of Riparian-Wetland Area: Tularcitos Creek

Date: August 10, 2004 Segment/Reach ID: Reach 2 PFC 904

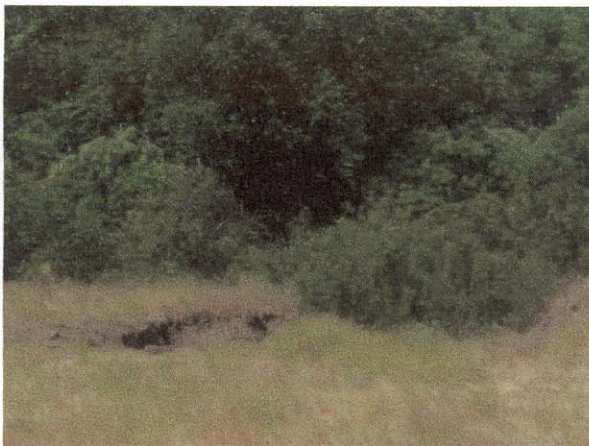
Picture 2

There are significant slides visible, and more ditches along the creek bank visible from the road (See Pictures 2, 3 and 4). These numerous slides from cattle trails are visibly contributing large amounts of sediment (See Pictures 3 and 4). The banks are extremely steep and vertically unstable.
