## Standard Checklist

Name of Riparian-Wetland Area: Potrero Creek

Date: June 17, 2004 Segment/Reach ID: Reach 2 PFC 103

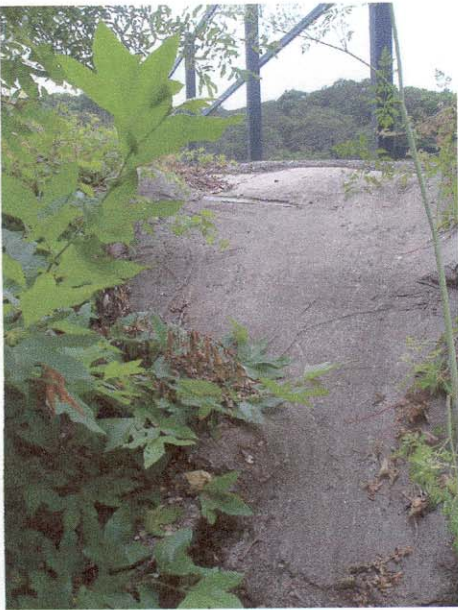
Picture 1

There is a concrete paved bank next to the tennis courts (See Picture 1).

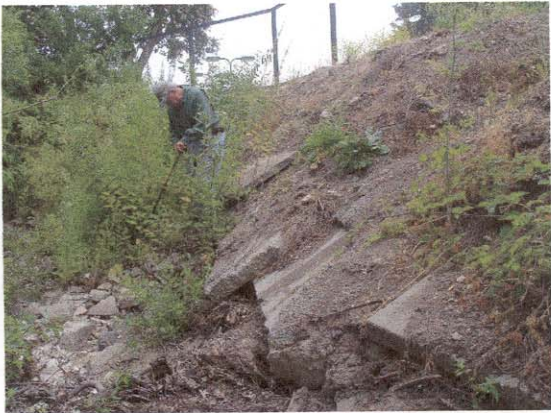
Picture 2

There are several sites along this reach where the concreted banks caved into the creek (See Picture 2)

#16 The system is not vertically stable where the concrete banks have caved in and a sink hole was formed.

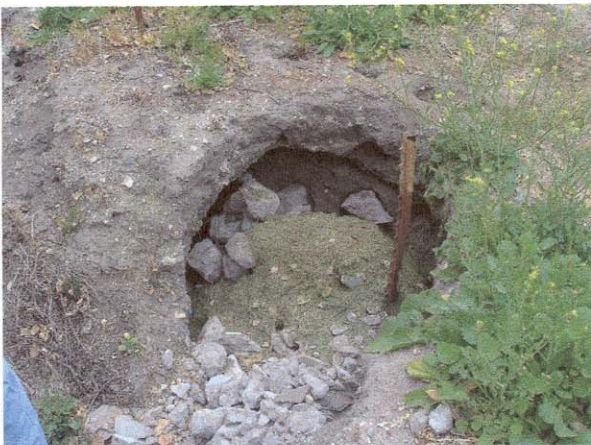
Picture 3

There is a sink hole next to the first collapsed concrete bank (See Picture 3).
