## Standard Checklist

Name of Riparian-Wetland Area: Conejo Creek - Intermittent cattle creek

Date: July 21, 2004 Segment/Reach ID: Reach 1 PFC 153 \_\_\_\_\_

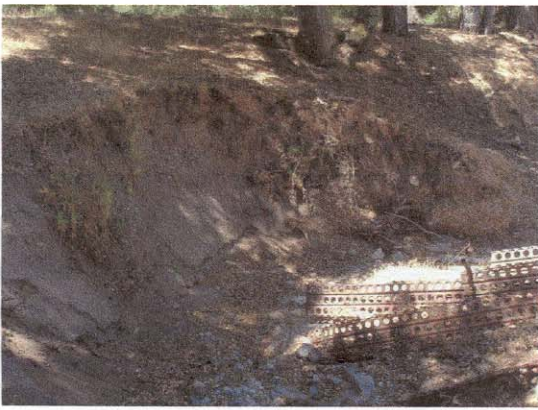
Picture 1

The creek is very sinuous. The entirety of the creek bed in the reach is under at least 4" sand, and much of the floodplains and pointbars present are composed of fine sands and are not revegetating with riparian plants (See Pictures 1,2 and 3).

There is one very large culvert under Carmel Valley Rd. that would function well, however there is a large eroding pool and bank immediately after the dirt trail that passes directly behind the culvert (See Picture 1). Another dirt trail has 3 non-functional culverts under it (See Pictures 5 and 6).

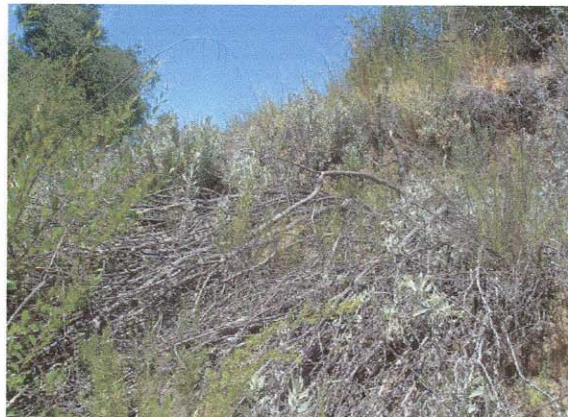
Picture 4

There were several dead alders (See Picture 4).

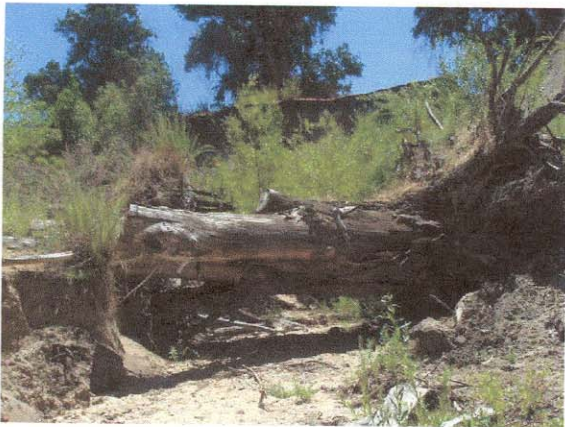
Picture 7

There are numerous cattle trails and the banks on either side are severely eroding. A few large trees are present as LWD however, there are not any more to provide LWD in the future (See Picture 7).
