Standard Checklist

Name of Riparian-Wetland Area: Robinson Canyon Creek

Date: June 25, 2004 Segment/Reach ID: Reach 7 PFC 204

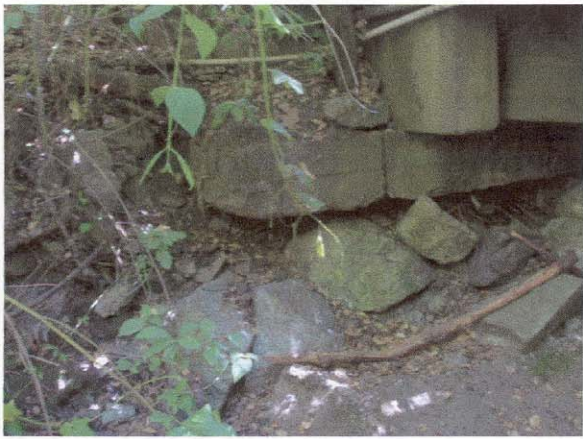
Picture 1

This reach began at a small private bridge (House 28395 Robison Canyon Rd.) that is being undercut (See Picture 1). There are large piles of sediment throughout the reach, including one pile over 20 ft. by 10 ft. that sits under a bridge that is being undercut (See Picture 6).

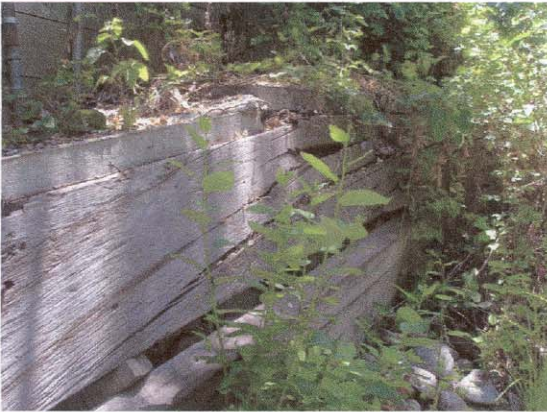
Picture 2

There were several sites where armoring had occurred. One bank had been stabilized with rocks and large beams is degrading and would likely not withstand a high flow (See Picture 2).

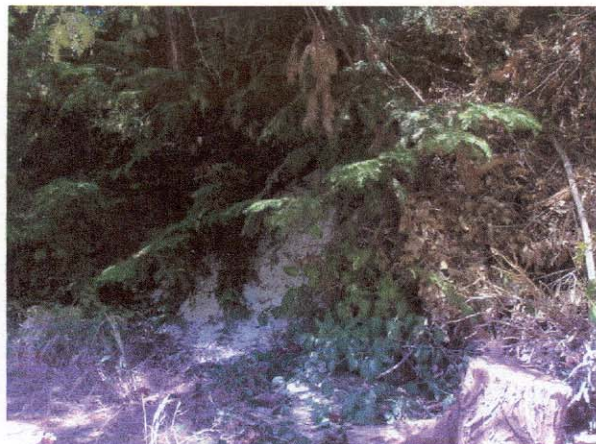
Picture 3

Much of the wetland vegetation consists of stressed, yellowing buckeyes and alders. There are a lot of upland species such as monkeyflower and genista present. There were no grasses seen, but there were some Redwoods at the beginning of the reach. There were two sites where trees have been cut down. One bank has been cleared below a backyard. There is shredded paper and yard waste under some trees on this bank (see Pictures 3 and 4).

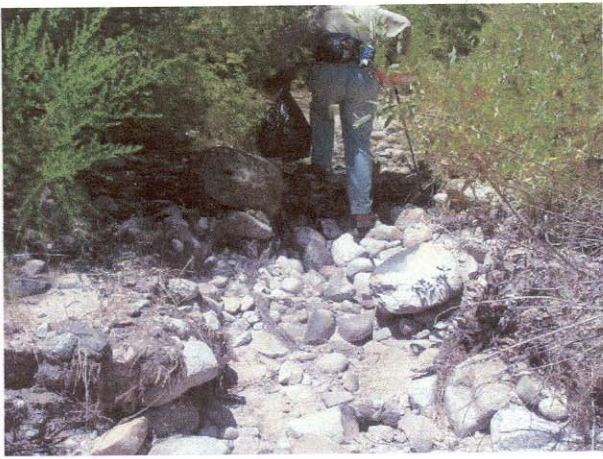
Picture 5

There was one site where headcutting had occurred. There is a 9" gradient difference (See Picture 5).

#16 There is headcutting and undercutting occurring in the creek.

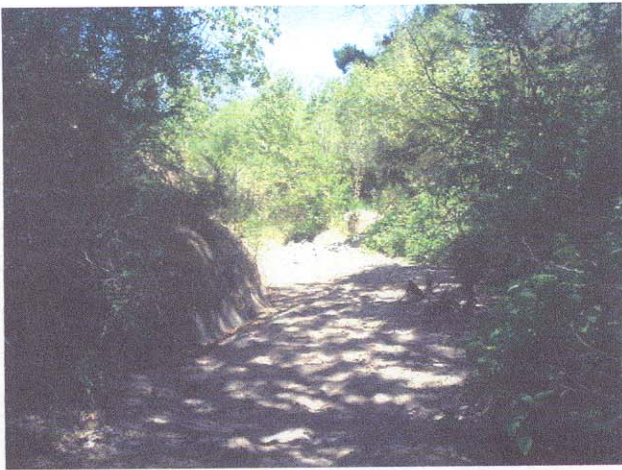
Picture 6

#5, 17 There is an excess of sediment throughout the reach.

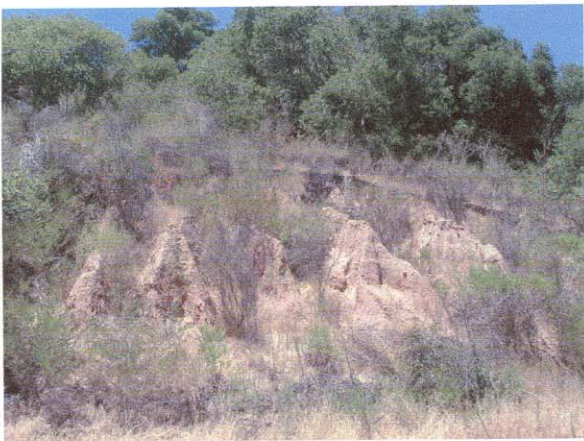
Picture 7

There was a large eroding hill of decomposed granite on the western upland side of the creek (See Picture 7).
