Standard Checklist

Name of Riparian-Wetland Area: Robinson Canyon Creek

Date: June 28, 2004 Segment/Reach ID: Reach 5 PFC 206

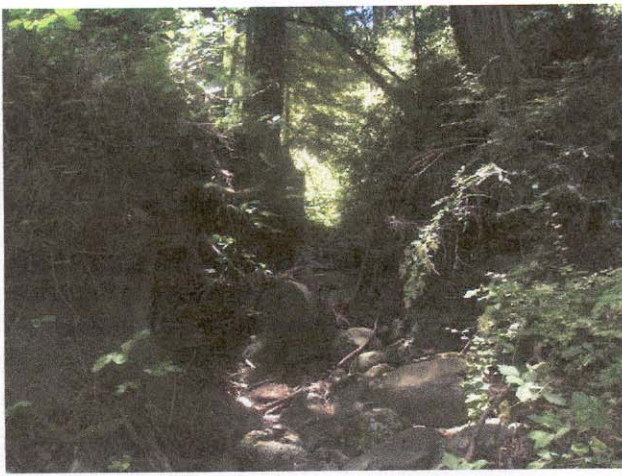
Picture 1

There is a large tributary creek with extreme incisement and erosion (See Picture 1). There is also a concrete bridge over the creek with two severely eroded culverts that are apparently unable to handle high flows as water flows underneath (See Pictures 2 and 3).
