## Standard Checklist

Name of Riparian-Wetland Area: Robinson Canyon Creek

Date: June 29, 2004 Segment/Reach ID: Reach 2 PFC 209

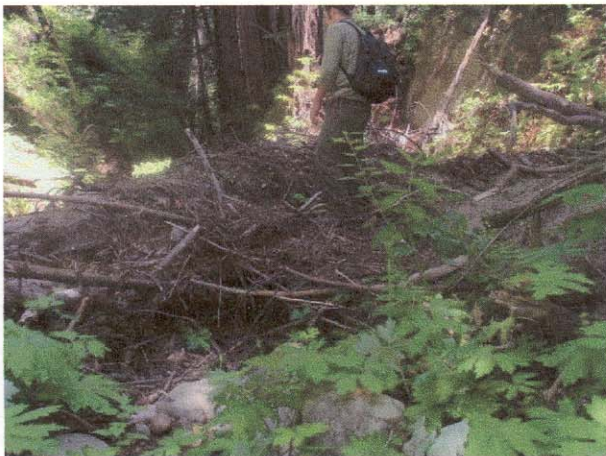
Picture 1

There are two sites with both landslides and logjams in this reach. If not removed soon, these two logjams will lead to more undercutting and erosion that will probably cause more large trees to fall (See Pictures 1 and 3). The upland has a very large eroding hillside along Robinson Canyon Rd. with failing vegetative stabilizers, along with one well and one large gas tank.

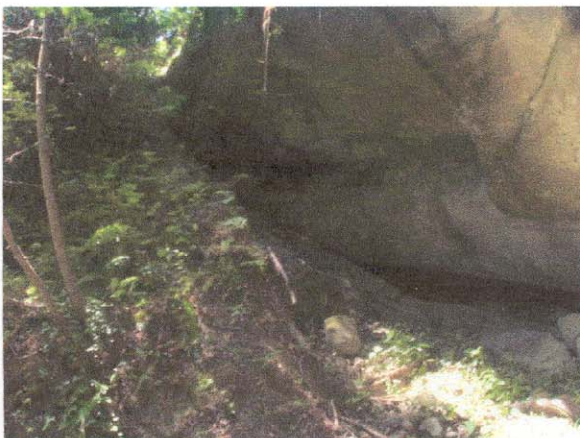
Picture 2

There is one undercut bedrock outcrop with several large sediment piles along it (See Picture 2).
