## Standard Checklist

Name of Riparian-Wetland Area: Hitchcock Creek

Date: May 26, 2004 Segment/Reach ID: Reach 6, 230 Esquiline PFC 306

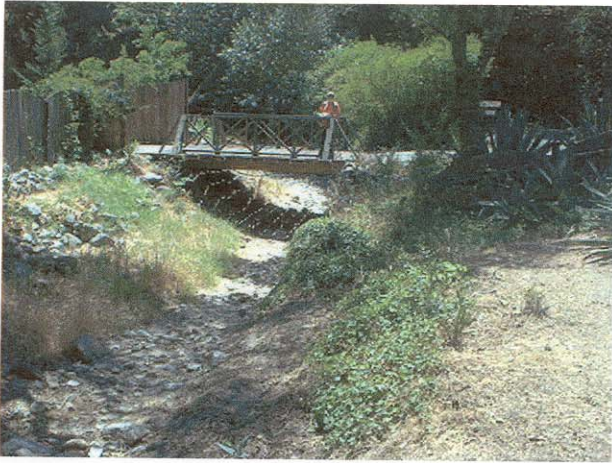
Picture 1

There is immense degradation due to armoring. At house 230 by the bridge, the bank protected by rocks is all caving into the creek (See Picture 1). There is also a gabion to stabilize the road side bank, however, this is sliding into the creek and sediment is eroding from the bank behind it. There is continued armoring upstream from house 230, which is stable for now. Sandbags on both banks are being washed away (See Picture 2 and 4).

There is almost no vegetation on either bank. The vegetation is not varied in age class or composition and only a few recruits were seen at the end of the reach (See Picture 1,2 and 4).

#6-9, 11-13 The vegetation is sparse and is not varied in age-class or composition. There are not sufficient root systems or channel characteristics to stabilize the banks or dissipate flow energies. (See Picture 1, 2, and 4)

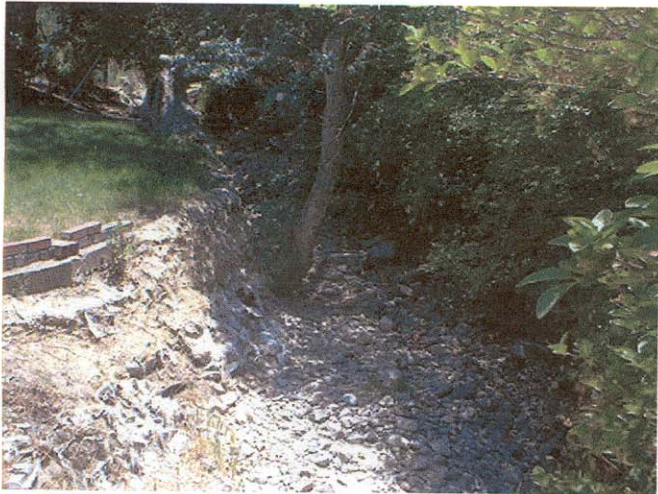
#16 The system is not vertically stable (See Picture 2 and 4)

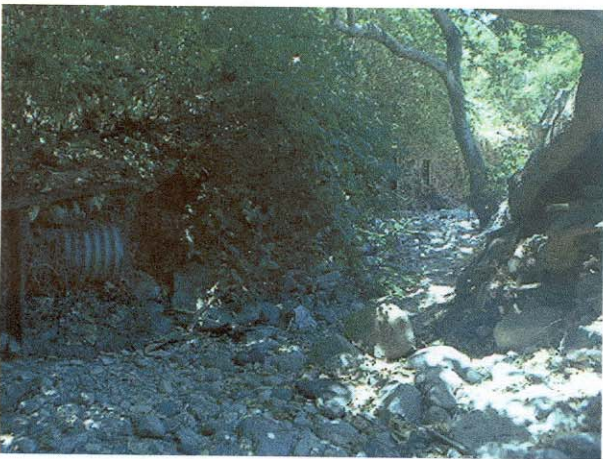
Picture 3

There are large sediment deposits and bank erosion throughout the reach. (See Picture 3)
