Standard Checklist

Name of Riparian-Wetland Area: Hitchcock Creek

Date: May 26, 2004 Segment/Reach ID: Reach 7, at Bridge 512 PFC 307

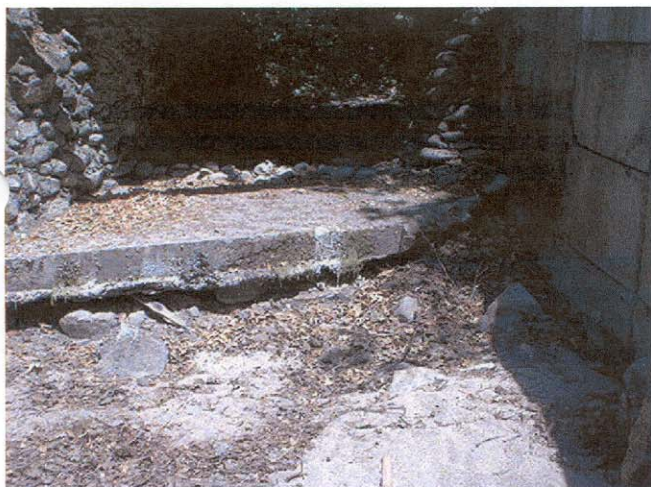
This reach lacks vegetation to properly stabilize the banks and dissipate flow energies. A great deal of concrete armoring has been done to stabilize the banks and hillsides (See Picture 1 and 2).

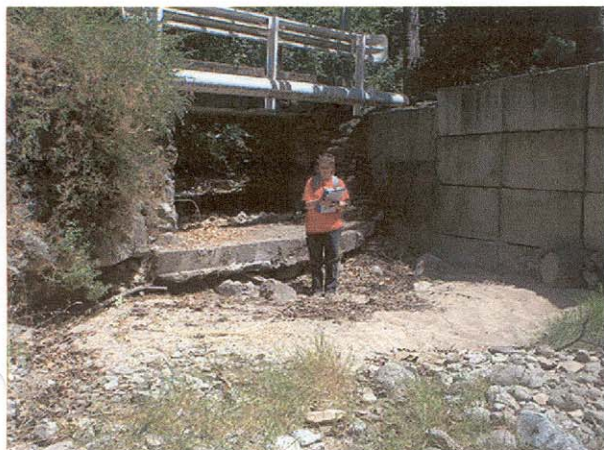
Picture 2

At the base of Bridge 513 is a huge sediment deposit. A hole that was 6 ft. deep at one time is now entirely filled (See Picture 2)

#5, 17 There is an excess sediment that has filled a 6 ft. hole and there is an excess of sediment throughout the creek.
