Standard Checklist

Name of Riparian-Wetland Area: Hitchcock Creek

Date: June 7, 2004

Segment/Reach ID: Reach 13

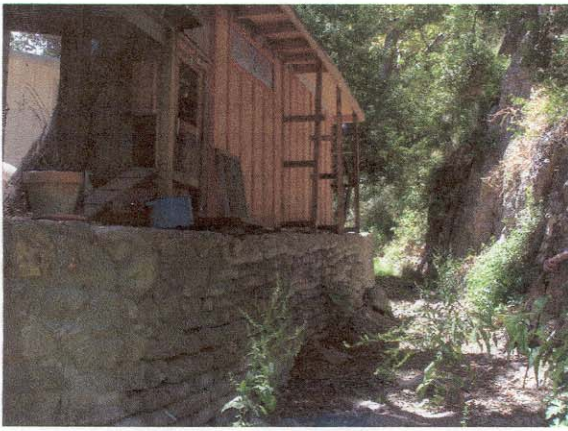
Picture 1

Where there is space for vegetation to grow in this reach there are enough trees, recruits and *Vinca major* but no grasses and only a few shrubs. However, a large part of the reach is between a bedrock wall and a shored up house foundation (See Pictures 1 and 2). This foundation has been shored up with concreted rock and sandbagged concrete (See Picture 1). The upstream part of the wall is beginning to be undercut, and there is some sediment deposition next to the downstream part of the wall.

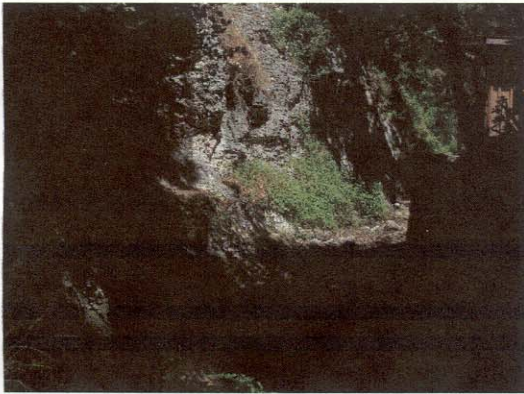
Picture 2

#13 Due to the cemented house foundation and the bedrock face this channel cannot dissipate energy.
