Standard Checklist

Name of Riparian-Wetland Area: Cachagua Creek

Date: July 20, 2004

Segment/Reach ID: Reach 11

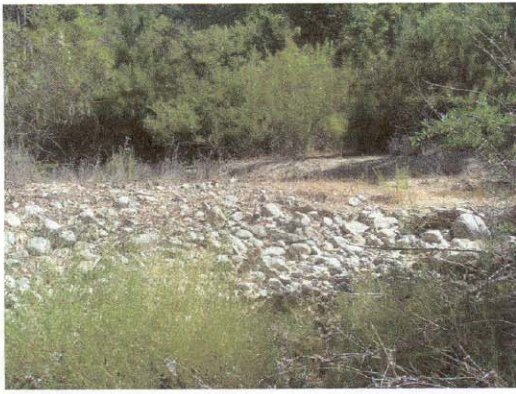
Picture 1

Flowing seepage and a healthy riparian corridor was encountered at the beginning of the reach. This reach seems to be an incised floodplain (See Picture 1).

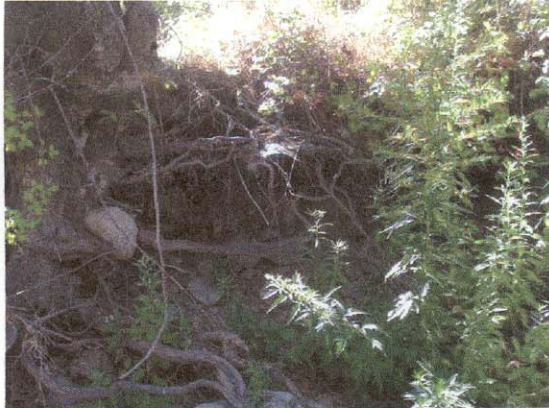
Picture 2

Some undercutting was observed along with a large sediment deposit and a sixty foot braided reach (See Picture 2).

#16 There were several instances of severe undercutting and the creek seems to be incised.

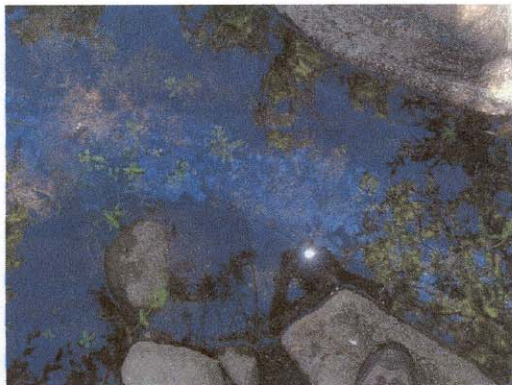
Picture 3

A section of the creek had an oily film on the water and another area had silty black water (See Picture 3).

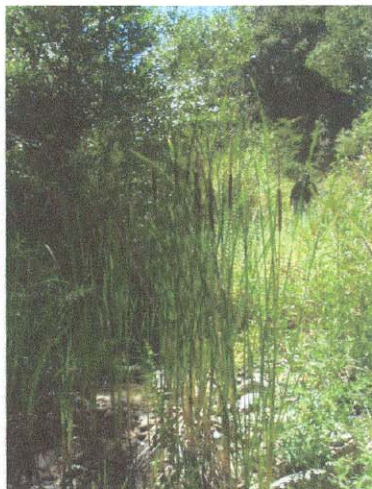
Picture 4

Cattail grasses were observed (See Picture 4), along with good spawning habitats.
5 YOY in one pool.

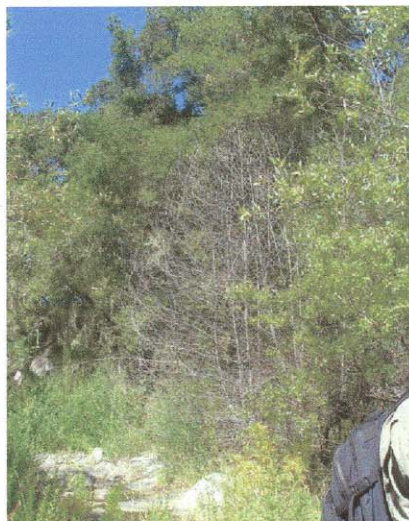
Picture 5

Six buckeyes were observed suffering and exhibiting early leaf drop. ~30 dead alders (See Picture 5).

#8, 9, 10, 11, 14 There were ~30 dead alders in on stretch and many buckeyes along the creek bed and road exhibiting early leaf drops. Much of the floodplains were bare or inhabited by upland species. In many places the only riparian-wetland species were willows, however they seemed vigorous.
