Standard Checklist

Name of Riparian-Wetland Area: Cachagua Creek

Date: July 13, 2004 Segment/Reach ID: Reach 9 PFC 407

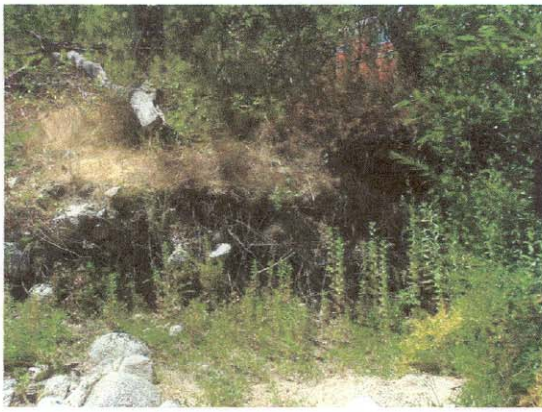
Picture 1

There are some eroding banks, a large floodplain that is void of vegetation, and several large sediment deposits (See Pictures 1, 2 and 4).

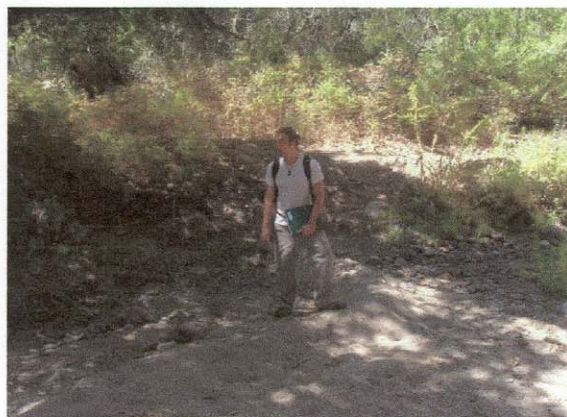
Picture 4

There is construction at various instances on each bank throughout the reach, and a bare cut road leading to the creek (See Picture 4).

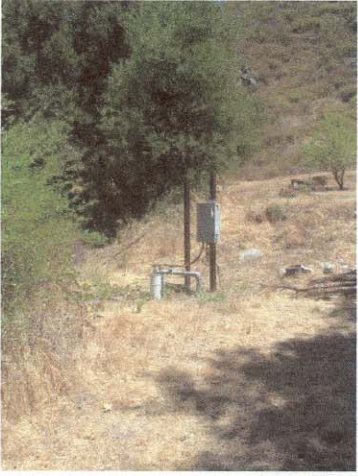
Picture 5

There are numerous residential pumps throughout this reach, especially on the northern bank. Some seem to be for livestock while others seem to have a residential purpose. In one instance there were two currently functioning wells in close proximity to each other (See Picture 5).
