## Standard Checklist

Name of Riparian-Wetland Area: Cachagua Creek

Date: July 9, 2004 Segment/Reach ID: Reach 5 PFC 411

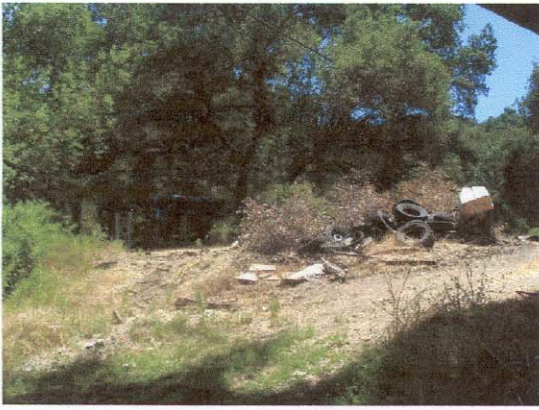
Picture 1

There is a cleared area with large waste piles of tires and appliances at house 21187 (See Picture 1). There is a spigot next to a PVC'd pipe or wires overhanging the creek (See Picture 2).

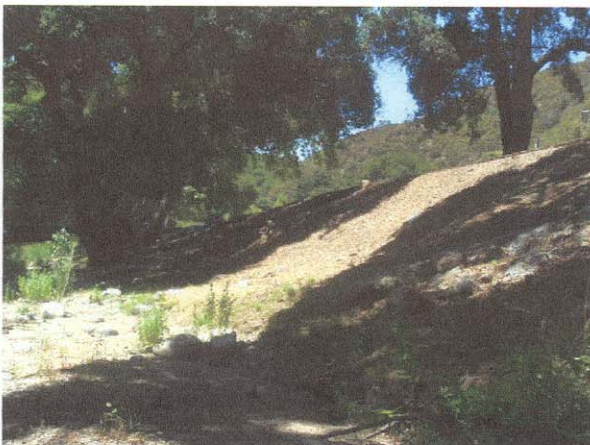
Picture 3

There is a completely bare large hillside that is being held up by an old oak tree directly behind the tennis courts (See Picture 3). There is a dirt ford that is functioning, however it has cut into the south bank, which is starting to erode into the creek (See Picture 4).
