Standard Checklist

Name of Riparian-Wetland Area: James Creek

Date: July 6, 2004 Segment/Reach ID: Reach 1 PFC 504

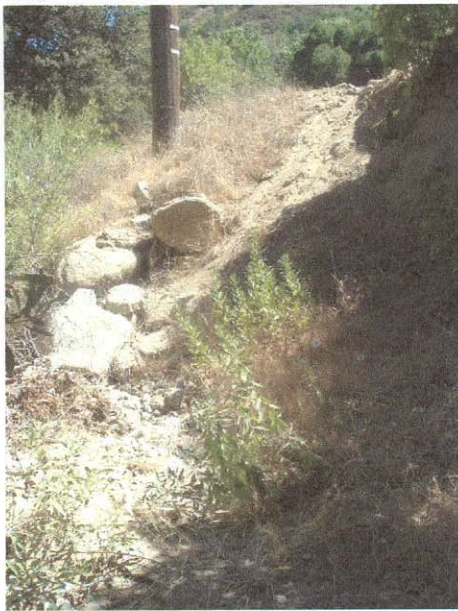
Picture 1

Yearly grading of the Tassajara Road results in large quantities of dirt being pushed over the side of the road and frequently directly into James creek (See Picture 1).

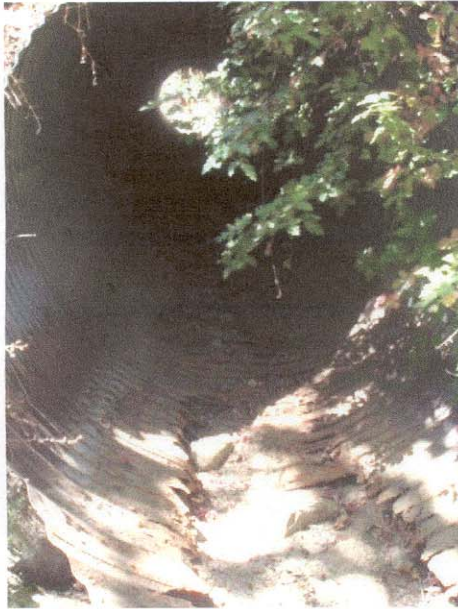
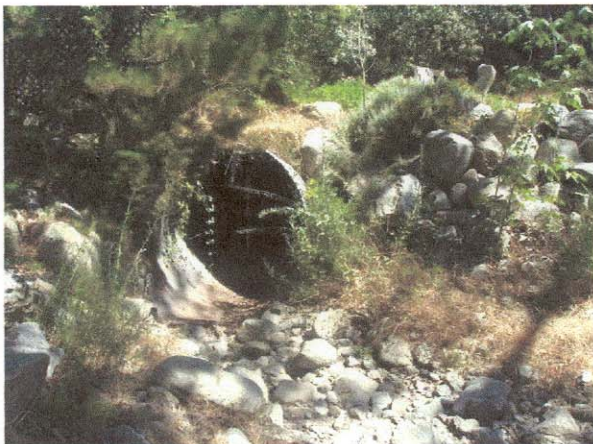
Picture 2

This reach begins two hundred yards upstream from the town of Jamesburg along the Tassajara Road. There is a disintegrating culvert between the first residence we passed and the road (See Pictures 2 and 3).

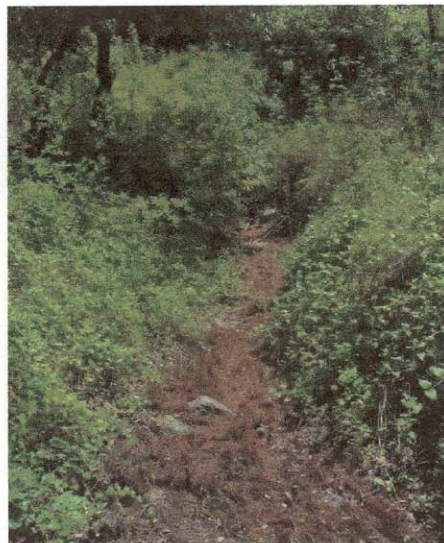
Picture 4

Throughout this reach there is an extreme abundance of upland species (poison oak, berry vines, nettles and genesta). There is a lack of willow and other riparian-wetland species with similar function (See Picture 4).
