## Standard Checklist

Name of Riparian-Wetland Area: San Clemente Creek (San Clemente Rancho)

Date: May 18, 2004 Segment/Reach ID: Reach 4 - By A frame cabin PFC 604

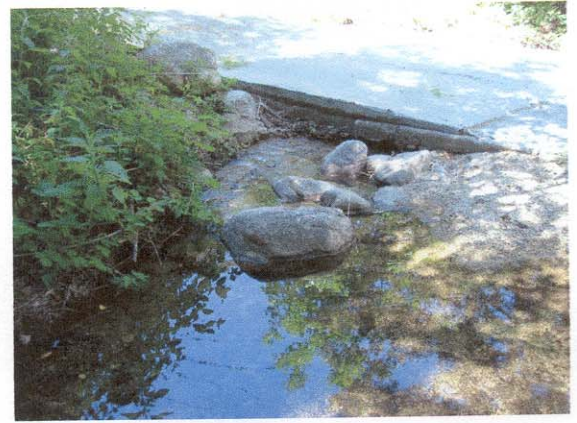
A concrete ford has been installed that is causing a large point bar to form on the downstream right side. It is currently being undercut on the downstream left side where a small amount of water is flowing underneath it. This ford is currently a fish passage impairment. It is apparent that strong and large water flows run over the ford because of the downstream presence of large tree trunks etc. The ford was laid over the remnants of an old culvert. Large debris is beginning to pile up between the logs and a large boulder on the downstream side. The owner has noted this and it is on his list to correct. (See Picture 1 & 2)

#5 There is an excess of deposition in the creek. The owners have noticed a drastic rise in the amount of sediment recently occurring in the creek that maybe caused by new roads & home development outside their property. (See Picture 1 and 3)

#17 There is excessive sediment deposition where the point bar is forming on the upstream side of the ford. This sediment is thought to originate in the upland watershed as previously mentioned. (See Picture 1 and 3)

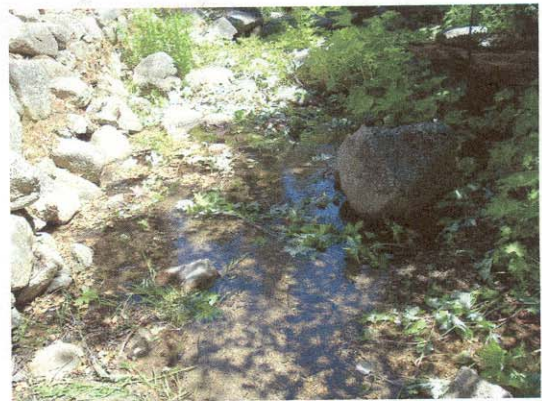
Picture 3

#16 Erosion is occurring on both banks on the immediate downstream side of the ford. Rock walls as seen in the last picture have been constructed to deter this and are currently working. There is some natural erosion on both banks. (See Picture 3)
