Standard Checklist

Name of Riparian-Wetland Area: Finch Creek

Date: July 27, 2004 Segment/Reach ID: Reach 3 PFC 712

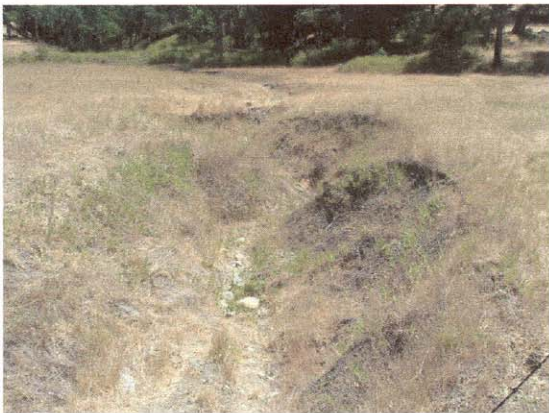
Picture 1

There are a few undercut banks and one landslide off of the county road above, where an attempt at stabilizing with boulders has failed (See Picture 1).

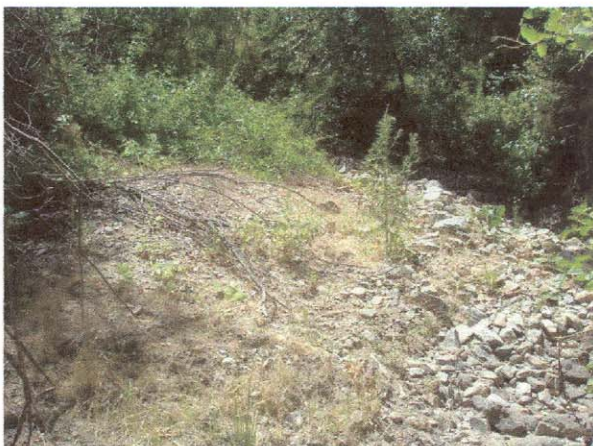
Picture 2

There is another tributary upland of the road that runs through a field that may be a sediment contributor (See Picture 2). There are a couple of pools in the reach where up to 30 yoy were observed.
