# Standard Checklist

Name of Riparian-Wetland Area: Finch Creek

Date: July 27, 2004 Segment/Reach ID: Reach 1 PFC 714

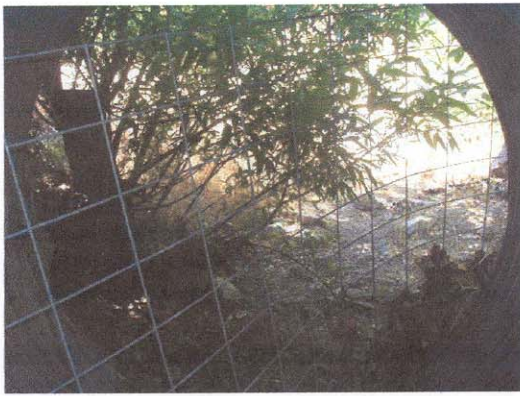
Picture 1

There are two six foot culverts under the Carmel Valley Road at the beginning of the reach, both of which have wire mesh screens on the upstream side. There are broken concrete slabs below the culverts and the culverts are undercut (See Pictures 1 and 2).

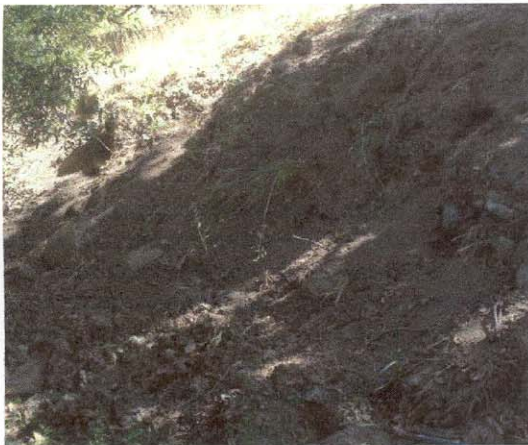
Picture 3

Throughout this reach, bank erosion and sediment deposits in the form of soil and mud are abundant (See Pictures 3, 4, 5, 6 and 8).

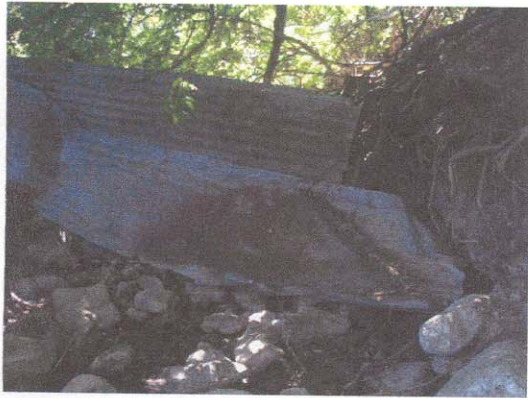
Picture 7

There is a large sheet of metal acting as a cattle blockade in the creek (See Picture 7).
