Standard Checklist

Name of Riparian-Wetland Area: Garzas Creek

Date: August 6, 2004 Segment/Reach ID: Reach 4 PFC 801

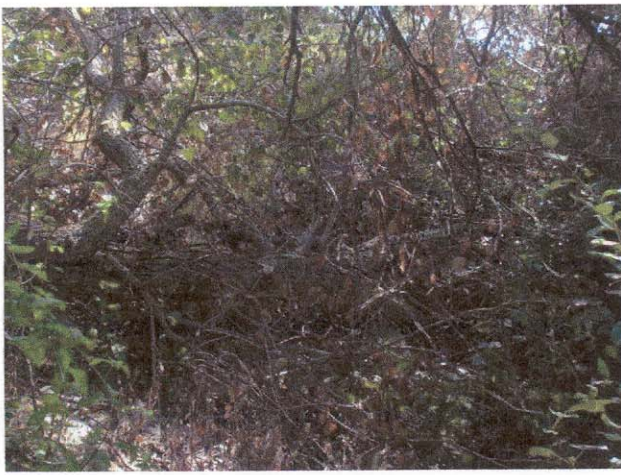
Picture 1

There is one large fallen cottonwood tree that needs to be removed (See Picture 1).

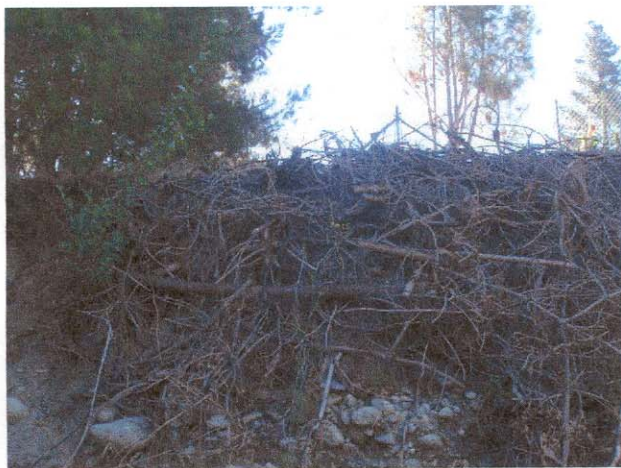
Picture 2

The southern bank has stacked yard waste that needs to be removed (See Picture 2).

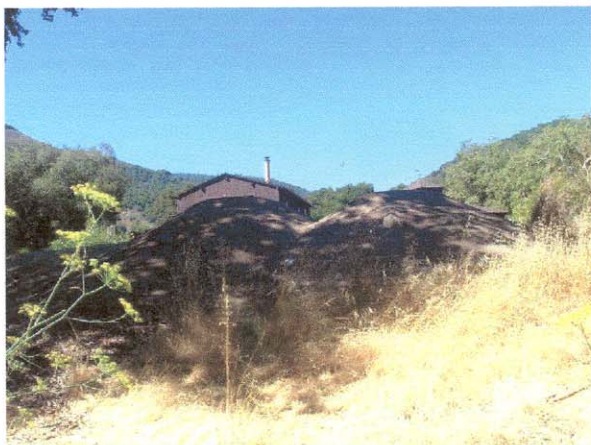
Picture 3

There are two dirt piles on private property that are near a side channel of the creek that need to be moved (See Picture 3).

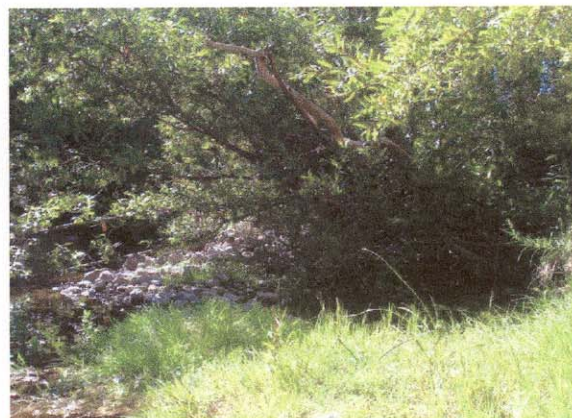
Picture 4

This reach ended at the confluence with the Carmel River (See Picture 4).
