Standard Checklist

Name of Riparian-Wetland Area: Garzas Creek

Date: August 6, 2004 Segment/Reach ID: Reach 2 PFC 803

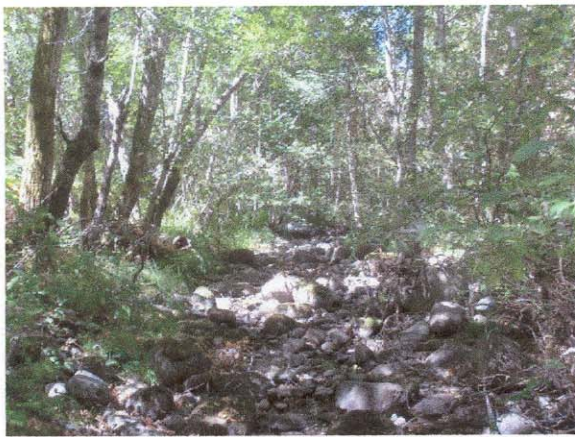
Picture 1

This reach is in PFC from the top of Redwood Creek Trail in Garland Park to the edge of Garland Park where private property begins. There vegetation is dense, vigorous and diverse in its composition and age-class (See Picture 1). However, dead alders were observed throughout the reach(See Picture 2).

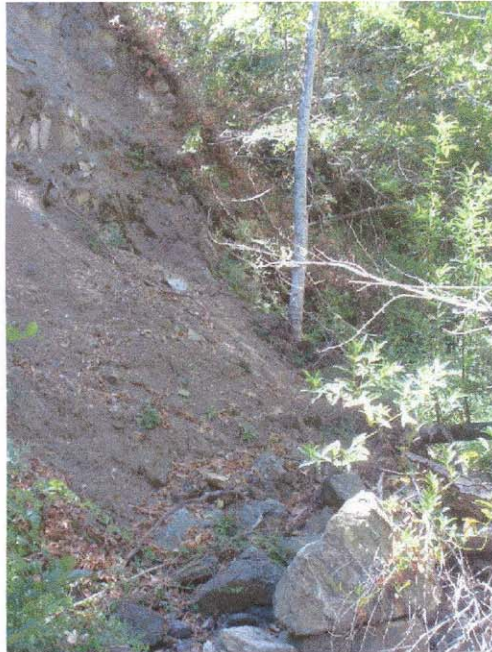
There is one dirt slide on the south bank, that flows directly into the creek. However, the observation of a healthy side channel suggests that this is a regular occurrence and that the system is capable of balancing this sediment contribution. (See Picture 3 and 4). GPS: N36,29.060 W121,45.562
