Standard Checklist

Name of Riparian-Wetland Area: Tularcitos Creek

PFC 905

Date: August 10, 2004 Segment/Reach ID: Reach 1

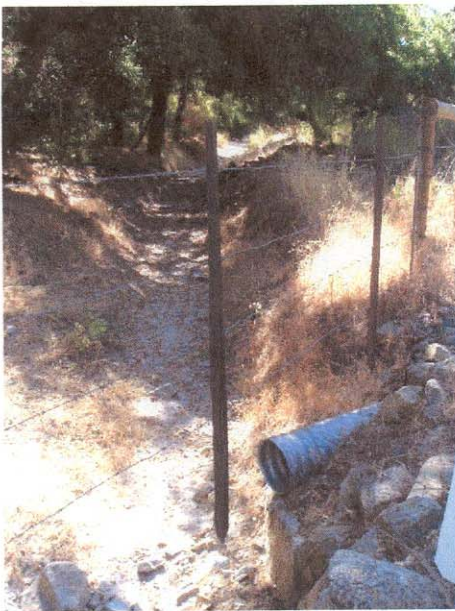
Picture 1

The vegetation is sparse with little ground cover, and very few riparian plants. Most of the vegetation on the banks are oaks, poison oak, berry vines and other upland species. Willows are the only riparian species present. (See Pictures 1, 2 and 3).

The banks are unstable and severely eroding. There are no visible cobbles or rocks in the creek beds, only fines. (See Pictures 1, 2, 3 and 5).

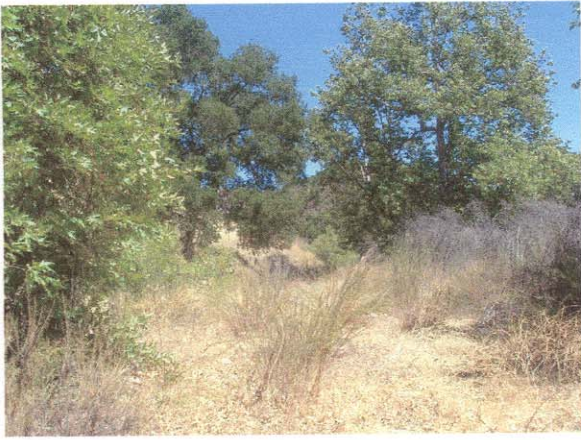
The vegetation becomes less sparse towards the end of the reach, yet still when the creek is visible from the road it is very incised. (See Picture 4 and 5).

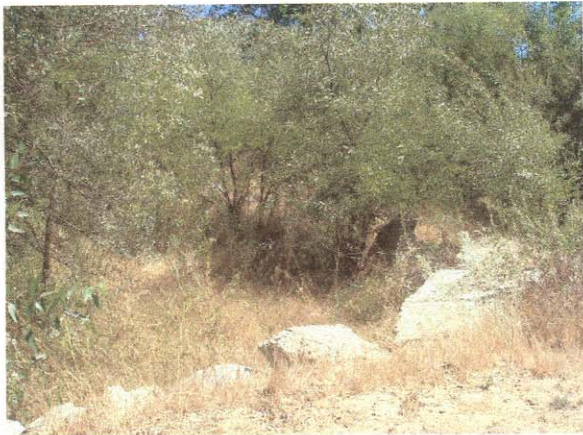
Picture 5

This reach ended at N36,26.551 W121,38.844 at driveway 33900 Carmel Valley Road with three culverts and old bridge or ford. (See Picture 5)
