X. RIPARIAN HABITAT MITIGATION MEASURES

C. Implement Riparian Corridor Management Program

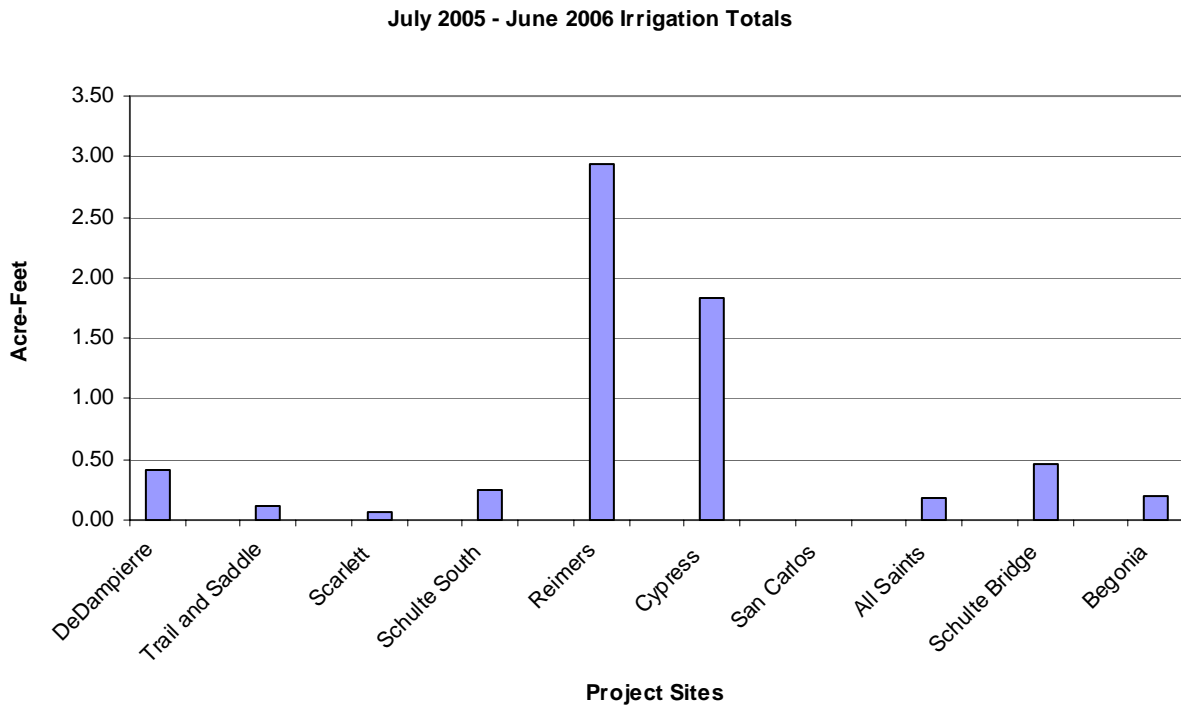
Figure X-1

Table X-2 and **Figure X-1** show water use for RY 2006. Please note that these figures include irrigation during two separate irrigation seasons. For the reporting year, 6.43 acre-feet (AF) of water were applied. The 2005 irrigation season began in May and continued through the end of November 2005. Total water use for the season was 6.30 AF. This compares to 9.46 AF during the 2004 irrigation season, and is considerably less than the 1994 irrigation total of 51.1 AF, when critically-dry conditions prevailed.
