*Central
Coast
Watershed
Studies*

**Carmel River
Large Woody Debris
Inventory from
Stonepine
To Carmel Lagoon
Fall 2003**

Report No. WI-2004-01
Submitted 31st March 2004
Final version 29th May 2004

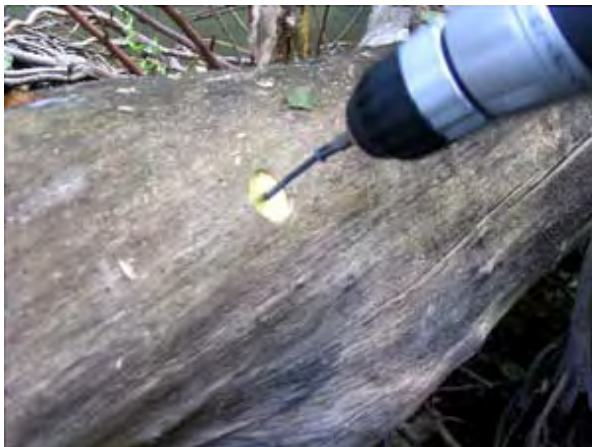
Figure 2: Attaching an identifying tag to a piece of LWD

California red-legged frog sightings reported here include a combination of positively identified individuals and frog sightings that were probably California red-legged frogs. Along the fifteen sample reaches, each occurrence of LWD or LWD accumulation was assigned coordinates and several kinds of data were collected (Table 1). Definitions of the data are provided in Appendix A. Sample data sheets are provided in Appendix B. We have provided digital photographs of 93 instances of LWD as part of the monitoring data. We have also tagged 29 pieces of LWD with circular brass-colored metal identifiers that will help track their progress in future studies (Fig. 2).

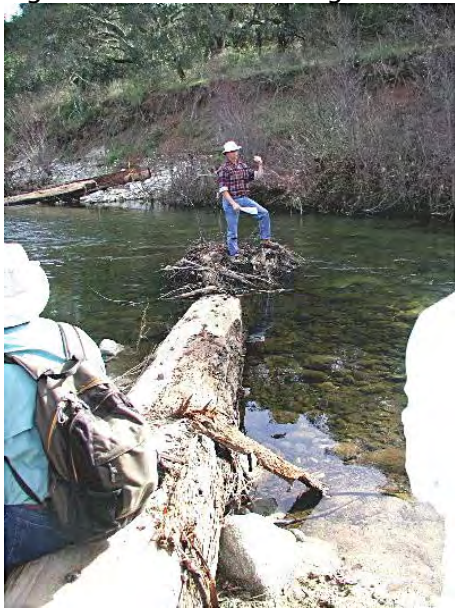
Figure 10: One of five large redwood logs placed near deDampierre ballpark. View upstream.

Thirty-five pieces of LWD (7%) in the survey were placed for river management purposes. We have been visually monitoring five large redwood logs placed near the deDampierre baseball park (Fig. 10). The logs were placed, angled upstream, to maintain a deep efficient channel and provide pool habitat. This reach has historically been the location of high sediment load that periodically fills and destabilizes the channel. Since installation of the log structures (2002)

there have been several minor flood flows. The installations are structurally sound and are providing significant pool habitat through forced hydraulic scour. The channel has developed and maintained a relatively low width/depth geometry as planned. This geometry provides a large hydraulic radius that is best for transporting sediment that might otherwise cause instability.

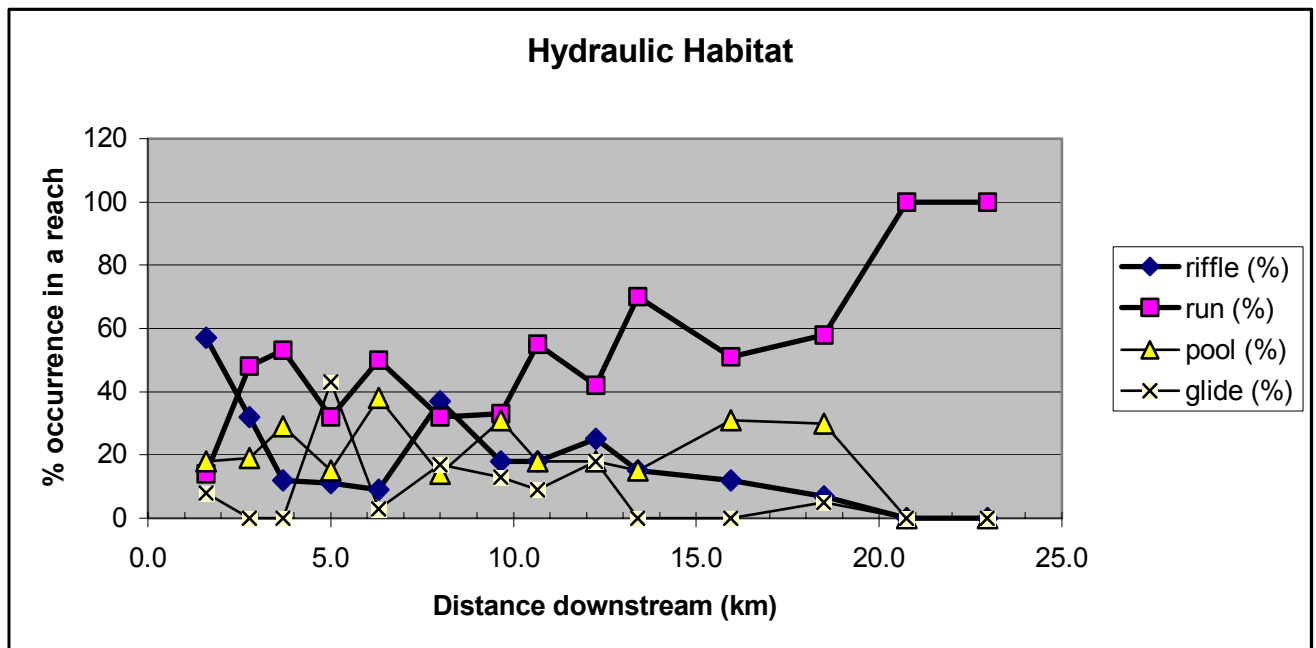
Figure 12: Changes in river hydraulic habitat with distance downstream from Stonepine Bridge.

Riffle habitat becomes less prevalent downstream as cobble and gravel substrates give way to sand. Run habitat takes the place of riffle in the river, especially after sand becomes the dominant substrate at 16 km (Fig. 12). The proportion of pools remains relatively constant.

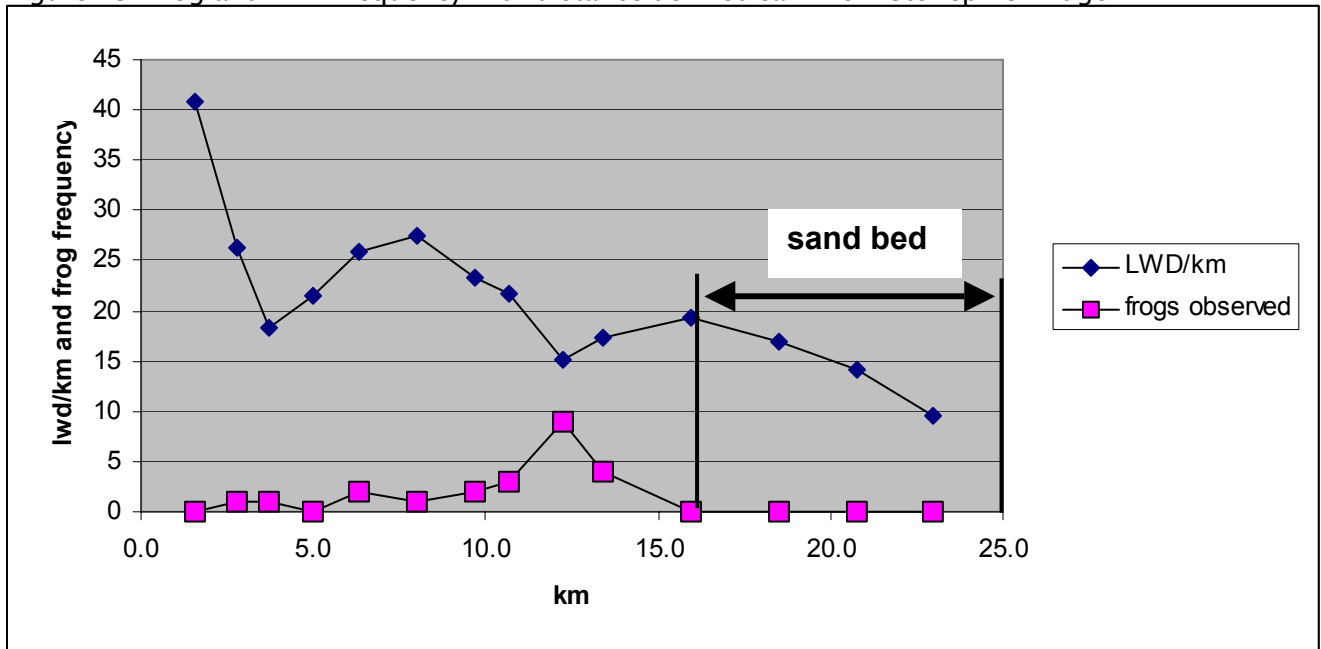
Figure 13: Frog and LWD frequency with distance downstream from Stonepine Bridge.

Fauna were noted on first approach to each LWD site (Appendix A). These biological data provide only anecdotal evidence of how the LWD is being used. The percentage of LWD bearing frogs increases markedly where there is a sudden decrease in available logs, suggesting that the population may be impacted by the paucity of LWD in that reach of the river (Fig. 13); however we note that there is not a similar increase in frog sightings where LWD decreases at 3.5 kilometers along the river. The sudden drop in frog sightings at a position of 16 km corresponds to the point at which the bed of the Carmel River turns to sand. The number of crayfish also plummets at 16 km. The lower two reaches of river were dry, eliminating the chance of finding aquatic fauna
