Standard Checklist

Name of Riparian-Wetland Area: Potrero Creek

Date: June 17, 2004 Segment/Reach ID: Reach 1 PFC 104

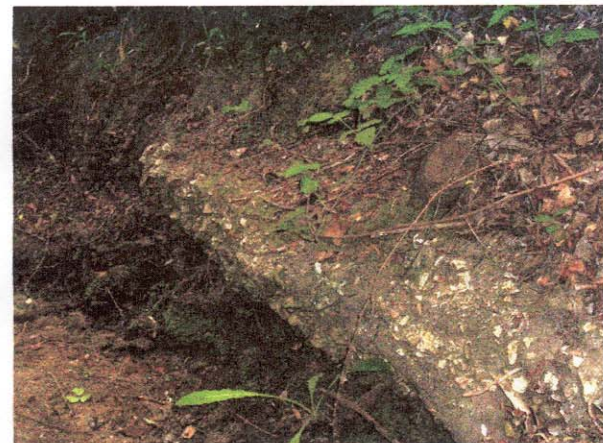
Picture 2

There is serious erosion just downstream where part of a bank collapsed, and headcutting and incising is occurring in the creek bed (See Pictures 1 and 2).

#5 The upland (Picture 2 and 4) is contributing sand and gravel, although the system seems to be handling it for now
